Safety Alert

ALERT 05 – 41

CARGO HANDLING OPERATIONS RESULTS IN FATALITY OF A SUPPLY VESSEL CREWMEMBER

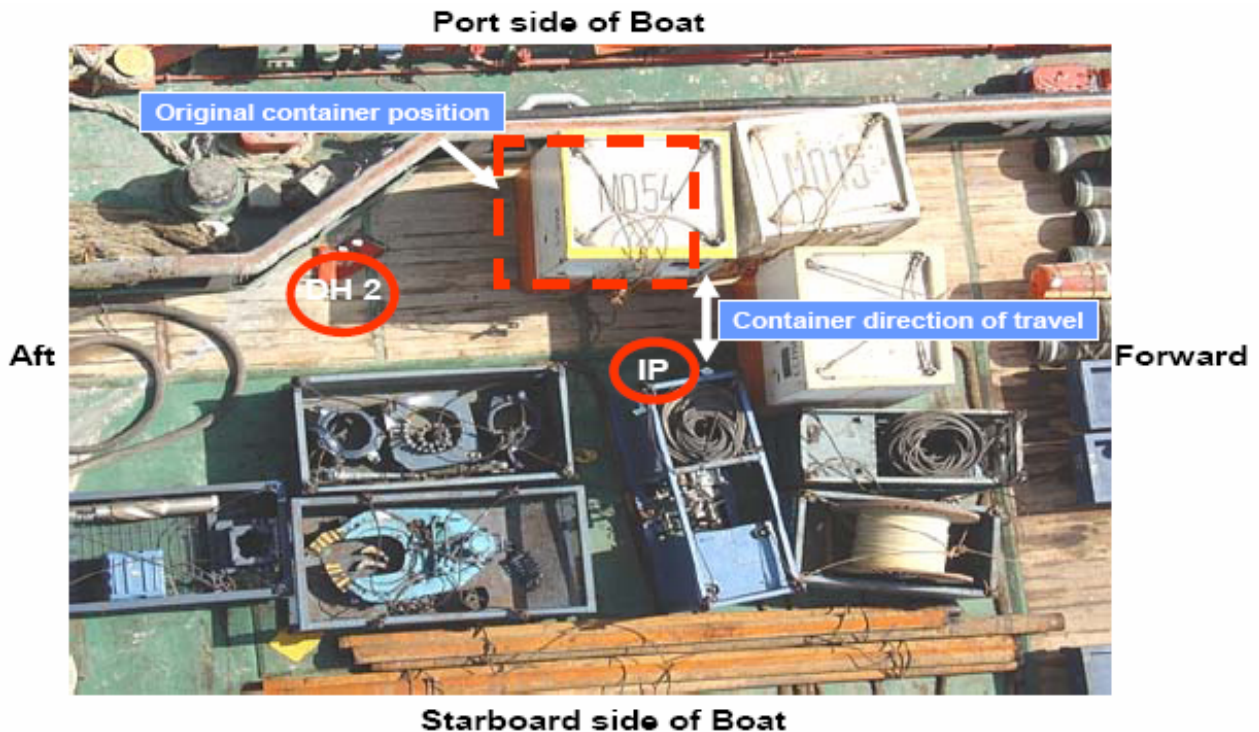
An offshore supply vessel was moored on the port side of a jack up rig. The vessel was moored at the bow with a back down buoy system and the stern was moored to the rig using the bow and port leg ropes. The supply vessel had already worked two other rigs prior to arrival and supply boat deck space was limited. The incident occurred just after the noon tour change when the on tour crane operator resumed cargo operations. Two supply vessel crewmembers were working as riggers on the boat deck. An empty chemical container was back loaded and spotted on the deck of the supply vessel, but as the crane operator started slacking off the hoist wire so the load could be detached, one of the two riggers hand signaled the crane operator to pick up a little so the load could be repositioned (pushed) closer to the other cargo. The crane operator complied by hoisting the container approximately one foot off the deck. As the container cleared the deck it unexpectedly appeared to swing 4 feet to the starboard side of the supply vessel and trapped one of the riggers between the swinging container and a power pack basket setting on deck. The man was crushed and immediately collapsed onto the deck. The man was transported to the rig's hospital and the medic performed CPR for approximately 30 minutes however he never regained consciousness, breathing or a pulse.

This was a very routine job that is successfully completed on a daily basis without incident. **Complacency may have been a factor.** The investigation determined that the boom tip was properly positioned above the load as the container was lifted for repositioning. The cause for the sudden movement may have been due to the beam sea that pushed the supply vessel to port making the load appear to swing 4 feet to starboard as it was suspended above the deck. This sudden motion is what caused the container to strike the stationary basket. **What we don't plan for can kill us. Planning:** A basic generic Job Risk Assessment was reviewed during the pre-tour meeting but the riggers on the supply vessel were not part of the risk assessment. This is not an example of proper risk assessment and if it had been task specific with all workers involved, these risks would have been identified and risk reduction measures put in place. **Communication:** The crane operator had radio communications with the supply vessel captain only. It was never established which rigger was giving hand signals from the supply vessel or what exactly the riggers plans were. **Communication should have been a priority and it was not. Environmental Factors:** The supply vessel was secured with three point mooring in a beam sea and was subject to a roll of 2 degrees to port and 2 degrees to starboard. **Were environmental conditions (vessel motions) carefully considered? Time Out** was not called and the job only stopped when a man went down. **Are we Proactive or Reactive?**

The planning, communication and procedures used to work cargo on this vessel were probably very similar to the many other vessels that have been worked, but with one exception, this time a man was killed. **Unsafe conditions** and **at risk behaviors** continued to add up and because nothing bad happened in the past so the job went on, business as usual. Is this how we do our business? If we allow ourselves to develop **high risk tolerance** and become comfortable working around things that should concern us, we become less likely to call **Time Out**. Something set this incident into motion and the result was a fatality. It was not identified what kind of training or safety culture the employees working on the supply vessel were exposed to or what tools they had available to manage safety on the job. What is known is the **training, safety culture** and **safety tools** our employees have available to manage safety. Regardless of who is involved we must work to our standards. If something is not right, stop and make it right. The photo above identifies the **CRUSH POINT**.
