Safety Alert

ALERT 05 – 42

NEAR MISS – MUD PUMP RELIEF LINE

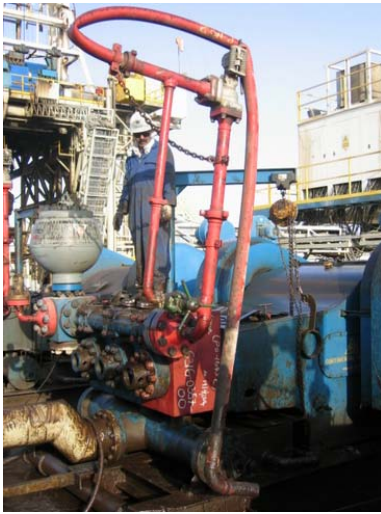
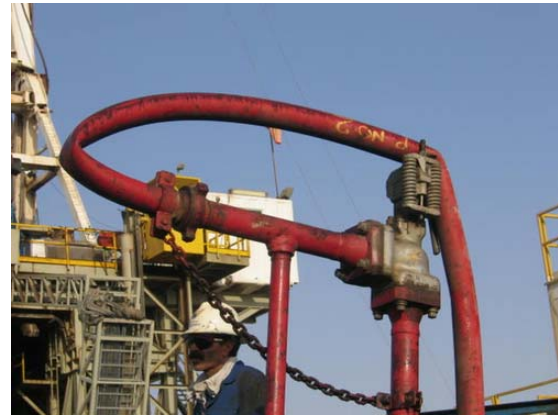
The pictures below show the outcome when the mud pump relief valve popped at +/- 4900 psi and the bolts on the anchor clamp on the mud tank failed. The rig had just repaired the module on the same mud pump and was back online circulating when the pop off blew. Fortunately there were no personnel present in the area and subsequently no injury to personnel.

This incident was a very serious incident and could have been fatal. We are currently conducting a full investigation on this incident and we are also internally reviewing our relief line configurations and design to eliminate the reoccurrence of this type of incident.

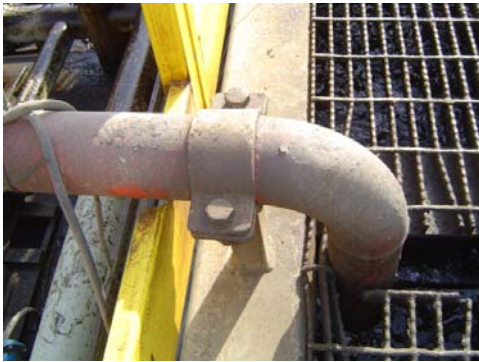
Normal configuration of the Mud Tank anchor bracket

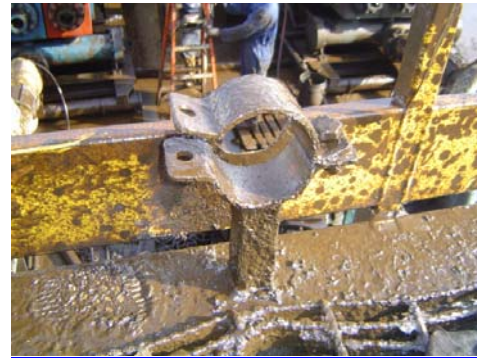
Mud Tank anchor bracket after the incident. Note handrail was also removed at the time of the incident.
