Safety Alert

ALERT 05 – 43

CRANE BLOCK SIDE PLATE DROPPED FROM BLOCK

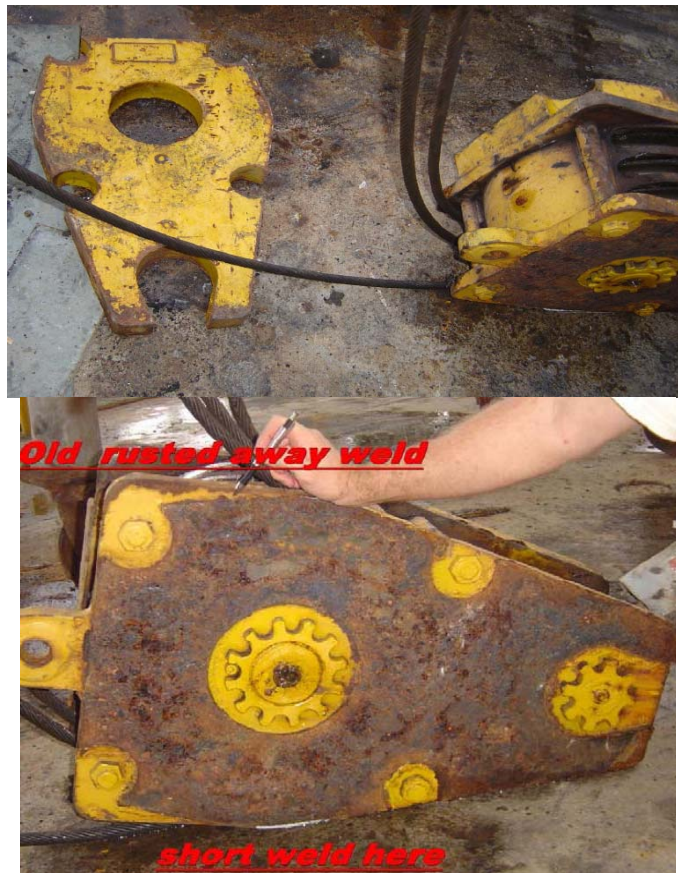
One of the weighted side plates, located on each side of the main block, fell to the deck while the crane was parked in a stowed position in the cradle.

It has been determined that the stitch welds had deteriorated to the point that they could no longer support the weight of the plate.

1. An immediate inspection is to be conducted of all crane main blocks. This to include but not limited to all Welds, Fasteners, Sheaves, Bearings/Bushings, Seals and Pins.
2. Worn or deteriorated parts are to be replaced and deteriorated welds are to be repaired as per the manufacturer's welding procedure.
3. This inspection will be included as part of the annual crane inspection.
