Safety Alert

From the International Association of Drilling Contractors

ALERT 06 – 05

DROPPED BUSHING RESULTS IN AMPUTATION OF TOES

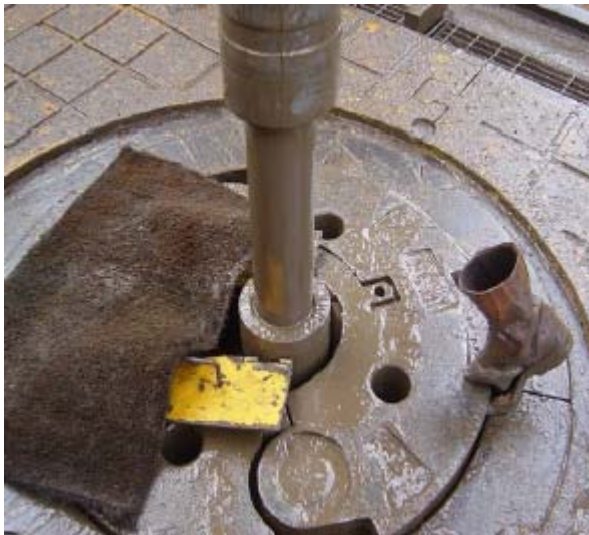
Operation at the time of the incident was pulling out of the hole with BHA and the Injured Person (IP) had just arrived on the rig floor to assist in the operation. A stand consisting of 2 DC and a hydraulic jar accelerator were being pulled through the rotary table when he arrived. The IP was standing with his left foot back on the non-skid mat and his right foot partially on the rotary. He was watching the driller waiting for him to signal to set the slips. The driller slowed the pulling speed as the jars came into the rotary table. The exposed mandrel of the accelerator came through the rotary but the lower squared shoulder of the outer body hung up on the underside of the inner bowl which were locked into position, thus lifting the master bushing approx. 6" –8". The sound of the accelerator contacting the bushings appeared to startle the IP who attempted to step backward quickly. He lost his footing, falling on the rig floor and thrusting his foot forward and under the bushings. Simultaneously the bushing fell to it's normal position trapping the IP's right foot. The IP's foot was trapped underneath the bushing, damaging his steel toe safety boot and amputating two of his right toes. The IP was treated on board and was subsequently Medevac onshore for further medical treatment.

- The IP was not fully aware of the operation on the rig floor and the hazards associated with the operation.
- The JSA did not adequately address this specific hazard.
- The supervisor and co-workers did not ensure that the IP was instructed about the work on going.
- The IP was looking in the wrong direction to see what was happening.

- ALL SUPERVISORS to ensure that when new persons enter the work place, the JSA MUST be reviewed with him.
- All Drillers to ensure that no one is to start to work on the rig floor without being briefed by the Driller.
- All JSA's to note: 1) the possibility of square shoulder tools becoming caught causing the bushing to be lifted and 2) everyone to be well back of the rotary until such tools are brought through.
