Safety Alert

ALERT 06-14

CAUGHT BETWEEN – SPOOLING CABLE RESULTS IN AN INJURY

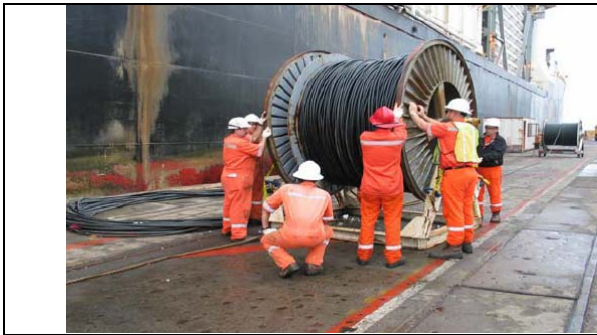
A crew was working dock side involved in a non-routine task of spooling off a multiplex control cable (MUX) from a rental reel directly onto a steel storage reel. The task was being conducted by manually turning the storage reel. As the task progressed, the reel became too heavy to manually turn. The job was stopped and an alternative mechanical method was devised by wrapping soft-line around the reel and pulling upwards with the rig crane, thus turning the reel. The crew commenced the rigging up of the soft-line and then normal operations were suspended to allow for a client safety seminar. The next day another crew continued with the task, however they did not use the soft-line and rig crane method as it had become too windy to use the crane. The decision was made to resume the spooling task by turning the reel by hand. The crew members were stationed on either side of the spool and between pulling down on the front and pushing up at the back they proceeded to rotate the reel to spool the cable. The injured employee was stationed at the right front of the spool and was pulling down by gripping the ribbed sections on the edge of the reel. As the reel turned, the IP's right elbow lodged against the frame of the reel and his arm became trapped between the ribbed section of the reel and the angle of the frame. This incident resulted in a compound fracture to the right forearm.

Position of crewmen when incident occurred.

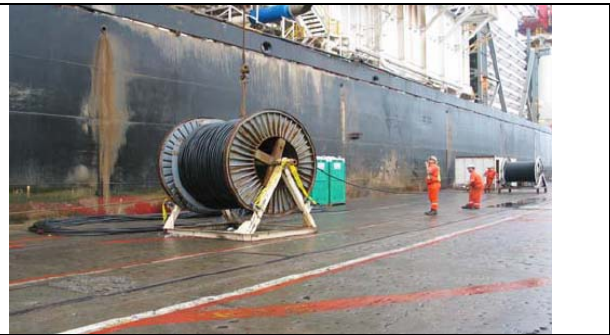
Use of rig crane and soft-line arrangement with Personnel kept at a safe distance.

- Instructed personnel to develop a Job Risk Assessment for this type of operation.
- Reviewed Risk Rating process with personnel involved.
- Reviewed Management of Change procedures.
