# Safety Alert

From the International Association of Drilling Contractors

ALERT 05 – 04

## FALL FROM MONKEY BOARD RESULTS IN A FATALITY

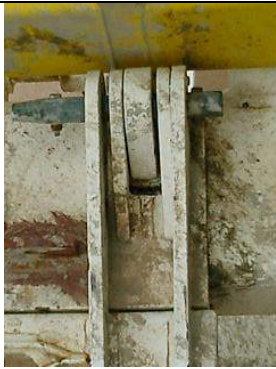
- The work platform had recently been modified when new fingers were fabricated and fitted.
- The two pins holding the walk platform also supported the segment of fingers. It is possible that when looking from above, the pins were viewed as being for the platform only with the fingers being part of the main Monkeyboard structure. This pin set up is as per original manufacture design.

View showing that one pin held both the grating and the finger assembly.

- Constant reinforcement stressing the importance of wearing the correct PPE and fall protection at heights.
- Constant reinforcement that all employees have the right to intervene or stop the job if it is not safe or covered by adequate controls.
- Review all Monkey Board operations on all company rigs.
- Ensure all company rigs are fitted with a secondary fall arrestor system on the Monkey Board.
- Develop procedures indicating all modifications are to be approved and tested prior to being put back into service.
- Review pin set up so that pins cannot be inadvertently removed.

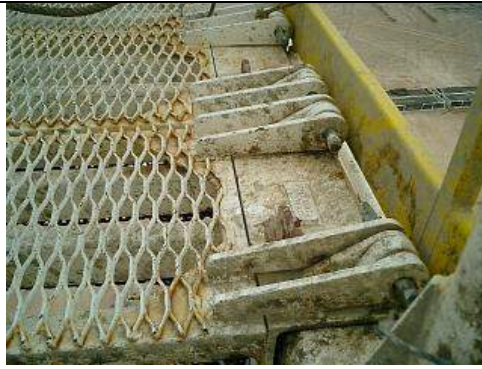
Side view of grating and Fingers attachment.

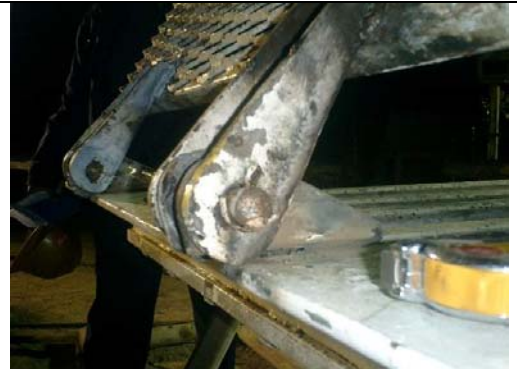
- The work platform could not be raised to the full vertical position because the backside of the pad eyes fitted to the platform came into contact with the Monkey board-supporting beam when the platform was raised to about a 45 deg angle.

Re-enactment of backside of pad eye rubbing at 45 deg angle. Actual restriction was on Monkey board beam.
