Safety Alert

From the International Association of Drilling Contractors

ALERT 05 – 12

DERRICK DIVING BOARD FELL TO RIG FLOOR

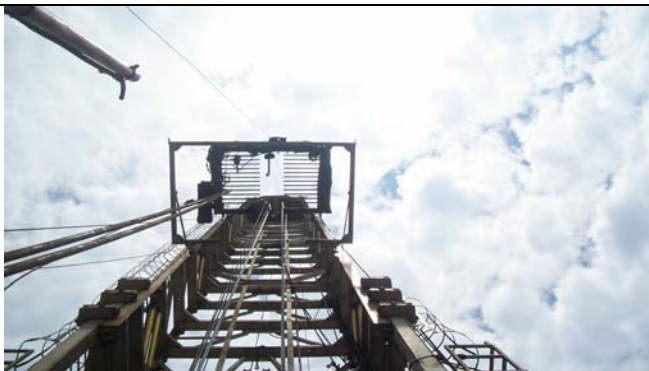
A 150 ton dual tubing spider and manual hand slips were being used for making up and standing back stands of 2-7/8" tubing, in the derrick. After running 18 joints of tubing and 6 blast joints into the hole, the driller started pulling and racking back whole stands of pipe. After the driller pulled and racked back the second stand, he started to lower the dual spider when it struck the derrick diving board. The blow to the board caused it to shear off from the racking board and fall 85' (28 meters) on to the strong back walkway located outside the rig floor area. Fortunately there were no injuries to personnel and limited equipment damage

- Safety slings that had once been installed on the derrick diving board to preclude the board from falling from the derrick had been removed at some time prior to the incident.

View of missing diving board

- Fixed safety slings connected to proper anchor points will be re-installed on the diving board when it is repaired and mounted into the mast
- Safety slings for the diving board will be added as a line item on the Mast Inspection Report for future inspections.
- The use of 150 ton dual tubing spider with large elevators will be discontinued and replaced with side door or center latch tubing elevators for this job.
- JSA's shall be written and reviewed by the personnel involved in the task and a concerted effort will be made to address all hazards, especially when conditions change.
- The driller must remove the Plexiglas window above him when tripping in/out of the hole to prevent his vision of the mast from being obscured and to allow direct communications.

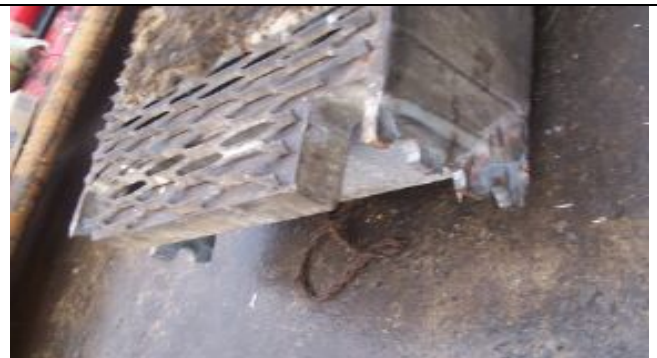
- Due to their size, the 150 ton dual tubing spiders being used were not designed to safely make up stands of tubing and rack them back in the derrick. This type spider will not pass the end of the diving board unless it is guided and oriented by the derrickman.

View of broken diving board padeyes
