Safety Alert

From the International Association of Drilling Contractors

ALERT 06 – 29

TRANSPORTATION FATALITY ACCIDENT

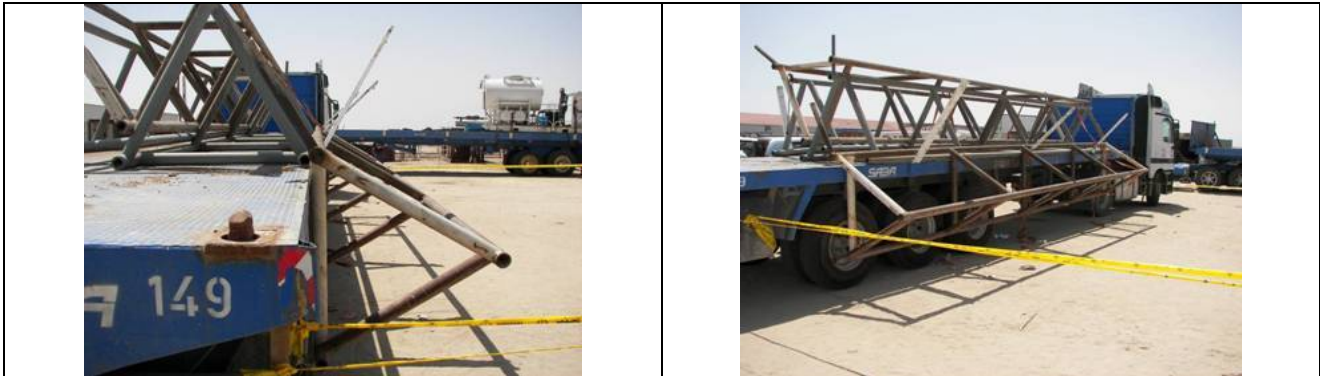
While moving rig equipment, a fatality and two serious injuries occurred at a pipe yard. When untied, the pipe rack fell, swung around and struck the side of the trailer. All three injured parties were struck by the falling pipe rack, two being pinned to the trailer.

1. The pipe racks were not loaded in a safe and stable manner and had not been individually tied down.
2. The tie down straps were removed before a secondary securing method was put in place (i.e. forklift).
3. All three injured parties were standing in a caught between position while releasing the straps.

1. There was a lack of written equipment transportation procedures including a written risk assessment for the specific task.
2. There was lack of competent supervision and the personnel performing this task were inexperienced. Because the personnel were inexperienced they had a lack of awareness and/or perception of risks involved and there consequences.
3. Because the crew was multi-national there was a lack of adequate communication.

- Implemented written procedures for rig move, including pipe racks. Procedures to include approved load configurations and necessary checklists.
- Required a dedicated "Transportation Supervisor(s)" to coordinate loading and unloading operations when performing a rig move. The transportation supervisor(s) must be onsite during loading and offloading operations. Ensure all supervisors are competent to the task and have formal training in rigging and tie down.

- To raise awareness of hazards and highlight control measures that need to be implemented rig personnel are to perform risk assessment for specific task. This assessment process should include all personnel involved in the operation (i.e. - rig and transportation contractors).

- Deployed suitable and adequate Safety/HSE personnel as required.
- Established approved vendor list and minimum standards of transportation companies.

- Sought measures to improve communication between all parties involved (i.e. – utilize interpreters, review hiring practices).
- Installed emergency call points within the company pipe yard with a direct line to the emergency services.

- Truck supervisors to be supplied with accurate emergency call out lists and a copy to be kept in each truck cab.
- Repositioned signs for the drilling workshop, detailing all the departments within the compound, to the roundabout opposite the main entrance.
