Safety Alert

From the International Association of Drilling Contractors

ALERT 06 – 33

DROPPED OBJECT - DERRICKBOARD SLIDE BAR INCIDENT

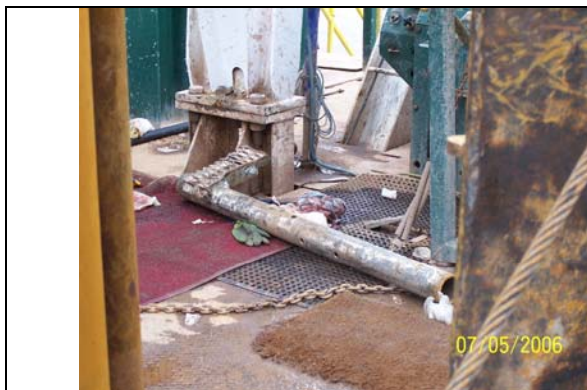
After laying down drill collars, the Derrickman positioned the Slide Bar across the derrickboard “alleyway” and came down to the rig floor. The rig crew and casing crew were rigging up to run casing. While using the rig floor hoist to pull the casing slips up the V-door, the Slide Bar fell from the derrickboard and hit the lay down stanchion (pole) in the mouse-hole. The Slide Bar ricocheted off the stanchion and struck a member of the casing crew in the back of the head, then struck the Assistant Driller in the left calf.

Several days earlier, the Slide Bar could not be retracted into its storage position and upon inspection, it was found to be bent. Due to safety concerns of attempting full repairs while the derrick was up, a decision was made to repair it temporarily and follow up with a permanent fix at the next rig move. Temporary repairs consisted of cutting approximately 8” off the length of the Bar to allow it to retract fully and then affixing a bolt with double nuts to prevent the shortened bar from working all the way out when extended.

After working the derrick that day, the Derrickman slid the Bar out of its retracted position but didn’t recognize the new double-nutted bolt and didn’t understand why it was there so he removed the bolt and slid the Bar on across the alleyway prior to coming down from the derrick.

Photo 1 – Slide Bar after falling to rig floor

- 1) Conduct Engineering design review and rebuild the Slide Bar assembly at next rig move.
- 2) Revise the JSA for working derricks to specify the proper configuration and positioning of the Slide Bar.
- 3) Improve Rig Manager Communication through the use of handover notes.
- 4) Distribute Safety Alert.

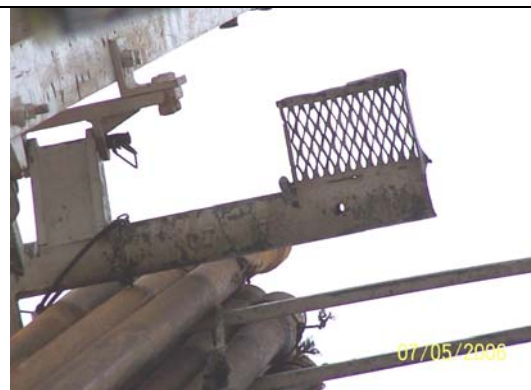
Photo 2 – Area of derrickboard from where Slide Bar fell
