Safety Alert

ALERT 06 – 34

NEAR MISS INCIDENT BREATHING APPARATUS - VALVE FAILURE

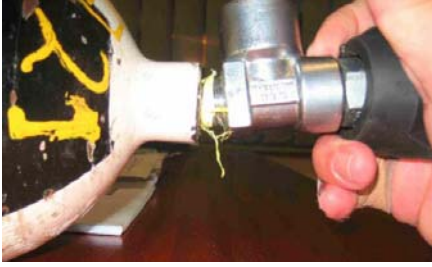
1. There was a definite bend and sign of stress in the threaded tube section of the valve.
2. The valve shaft was bent under the rubber tap cover.
3. The threads were squashed on one side of the threaded tube section indicating it had been bent at some stage.
4. The cross section of the break in the threaded tube section is dull and looks like an old break.
5. There is a section on one side that is considered, due to its shiny surface, to be a recent break and it has a sheer or tear appearance (photos attached).

Valve alignment with BA bottle and bent valve under rubber cap

1. Continue with integrity testing program.
2. Visually inspect all cylinders for damage or corrosion.
3. Place signs in the ERT container indicating the need for visual examination of all bottles prior to and after use.
4. ERT members and other BA users to be briefed on the incident reinforcing the need for care, handling and inspection
5. Restate the need for reporting any incident which may have damaged a BA cylinder.
6. Safety Alert to be sent to all operations and the company alert database.

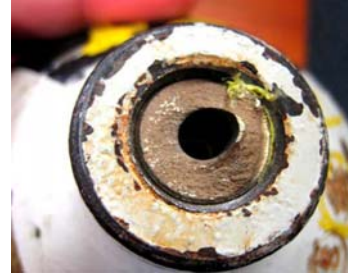
Cross section showing new and old fractures
