# Safety Alert

From the International Association of Drilling Contractors

## ALERT 06 – 39

### INCORRECT HEATER ON TRACTION MOTOR RESULTS IN FIRE

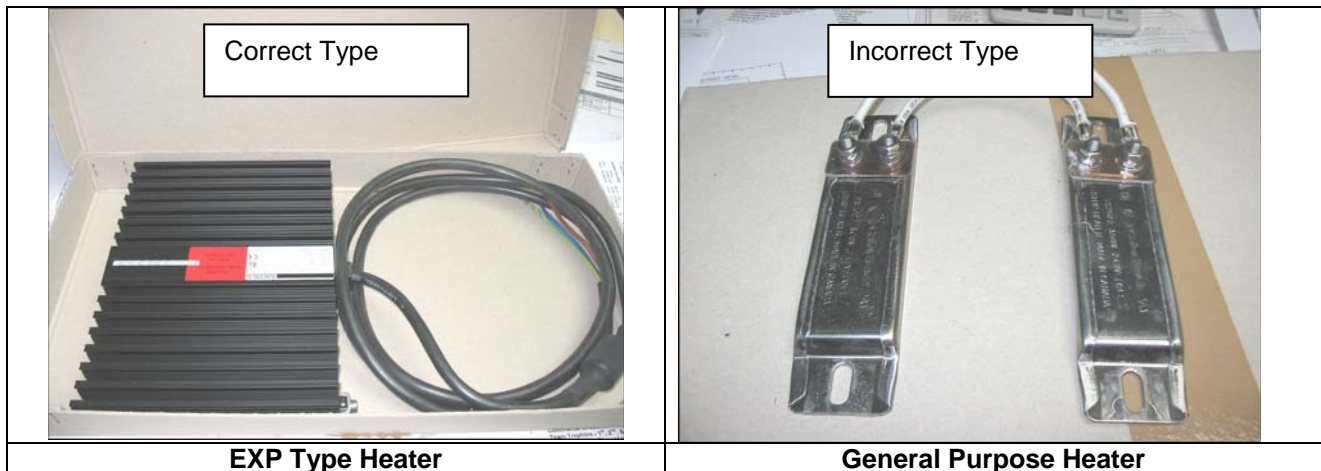
Gas from the well bore collected under the rig floor and ignited.

Investigation determined that the gas also filled the rotary drive traction motor which was equipped with a general purpose space heater. General purpose space heaters are not designed to maintain temperatures below flash points. The space heater provided the source of ignition.

Ensure that all rotary drive and drawworks traction motors are equipped with EXP heaters. If they are not, immediately remove power from the heaters and order replacement heaters. Each rig will be required to verify completion of inspection. All inspections and material requisitions should be completed and faxed to the Corporate Maintenance Department.
