Safety Alert

ALERT 09 – 25

HIGH POTENTIAL INCIDENT – DROPPED LIGHT

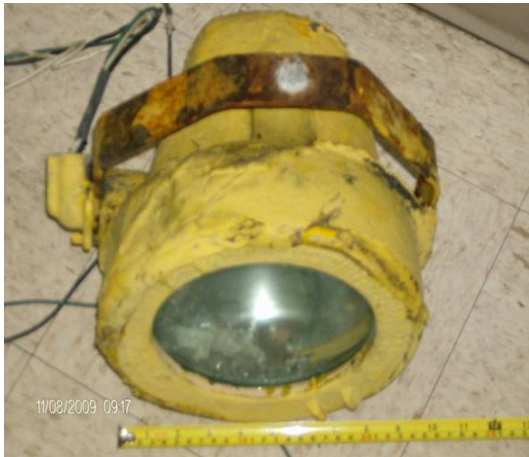
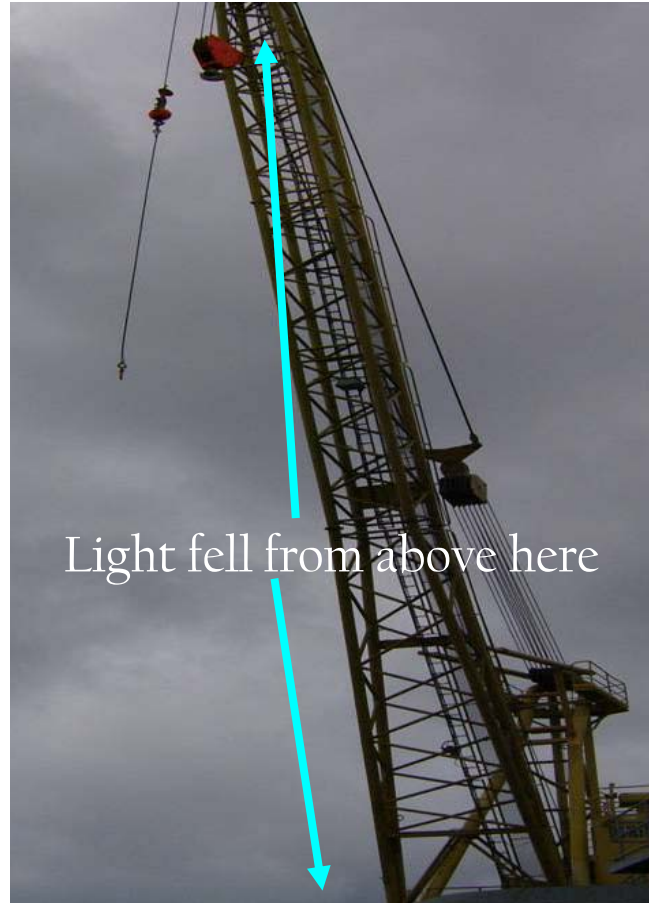
A 23 lb spotlight fell 90 feet (27.5 m) from a crane boom to the rig deck. The operation at the time was slewing the bow crane to over the chemical hatch from its stowed position at the forward leg. Having visually confirmed that the hook would not catch on any equipment on the radio room roof, the crane operator started to slew the crane toward the accommodation. As he did so the light fell to the deck beside the blue container pictured below. It then bounced and struck the wall of the radio room before coming to rest in the position shown. No one was in the area at the time of the incident.

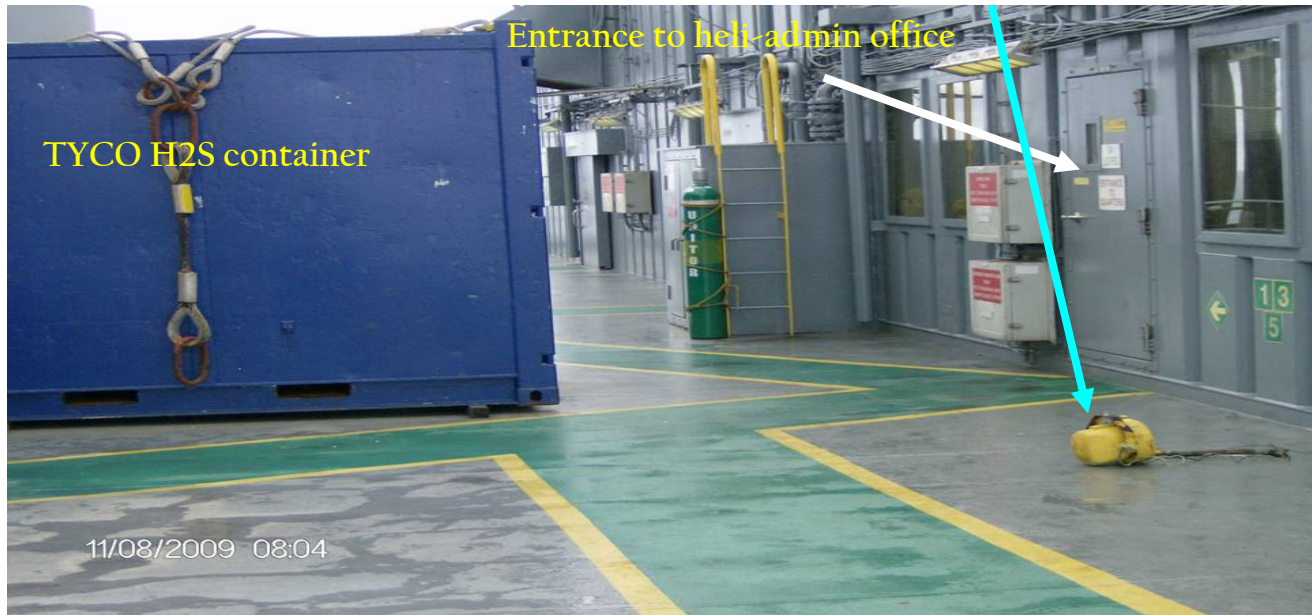
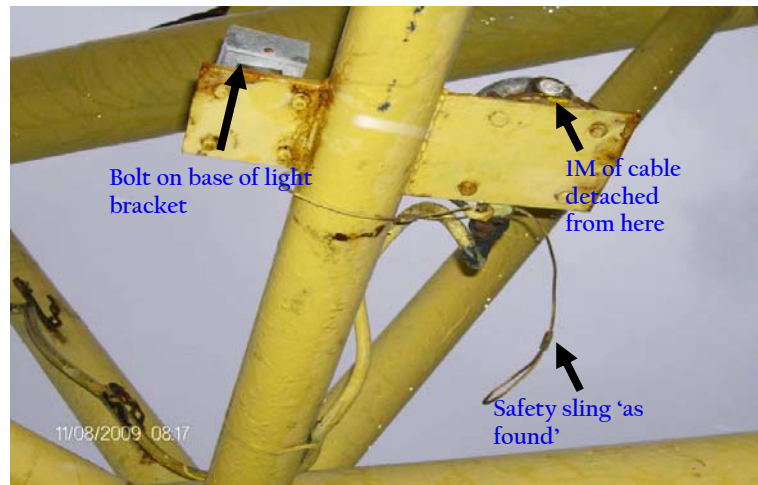
1. The secondary retention wire was not properly attached to the light. Therefore it did not retain the falling light.
2. The vibration mounting was not as per original OEM recommendation.
3. The crane lights are not included in any maintenance, inspection or Dropped Object Survey.

1. A Review of SAP/ Tour Inspection / Crane reports is to include crane lights and retention.
2. DROPS inspection to include the rest of the Rig, i.e. cranes, not just derrick.
3. All repairs must have OIM and/or Engineering Approval.
4. The crane manufacturer was asked to review the lighting arrangements for cranes and provide recommendations.
5. Instructed rig and maintenance personnel that all secondary retention cables on potential dropped objects are to be checked for correct attachment, length and corrosion.
6. If light fittings are not required, remove them.
