Safety Alert

ALERT 09 - 26

LIFTING OPERATION RESULTS IN ARM INJURY (LTI)

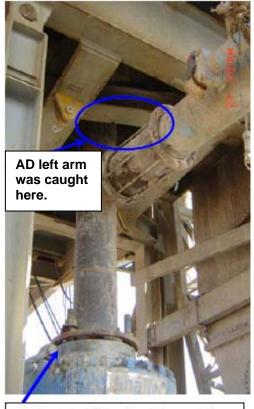
After nippling up the BOP stack the crew was installing the flow line from the shale shaker. The assistant driller (IP) was standing above annular preventer trying to connect the flow line's dresser sleeve with the bell nipple. He was holding the dresser sleeve with his left arm. The flow line was being lifted by the carrier hydraulic hoist, which created a blind lift. When he requested that the flow line be lowered a little, the night pusher ordered a new floor man to operate the carrier's hydraulic hoist instead of asking the driller to operate it. The new floor man operated the hydraulic hoist excessively upwards, which squeezed the assistant driller's left arm between the dresser sleeve and the beam located above the sleeve, causing a compound fracture to his arm.

- 1. Using carrier hydraulic hoist to lift the flow line instead of using the crane.
- 2. The injured person was in an improper working position and there was a failure to identify job hazards (JSA).
- The company's "Hoist 3" men operation system was not implemented and/or discussed (Quality of Pre-Job Safety Meeting).
- 4. Inadequate leadership as new and/or untrained person was assigned to operate the hoist.
- 5. JSA for the job was not adequate.

Assistant driller standing position

- 1. Instructed the rig crew to use a crane when lifting the flow line instead of using the carrier's hydraulic hoist.
- 2. Implement the company's "Hoist 3" men operation system when using air hoist and/or man riding.
- 3. Supervisors were instructed to assign duties based on competency.
- 4. Rig crews and rig supervisors were instructed to initiate (develop) a correct SJA (JSA) to cover nipple up, nipple down BOP and install flow line. This new SJA (JSA) is to be communicated with all drilling crews.
