**Safety Alert** From the International Association of Drilling Contractors

## ALERT 11 – 01

# SAND LINE FLAGGING OPERATION RESULTS IN FATALITY

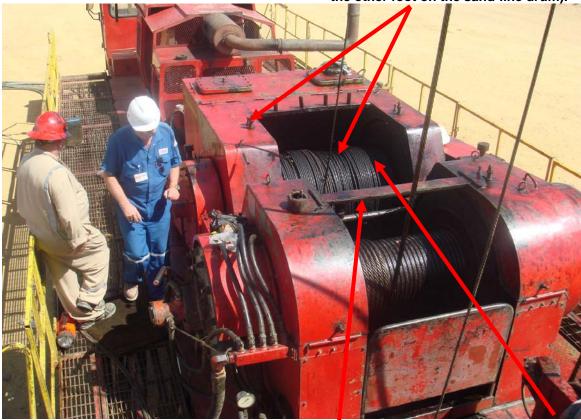
Location of the fatally injured person at the time of incident (one foot on top of drum housing and the other foot on the sand-line drum).

Location of the second individual (one foot on the sand-line drum and one foot on a lower bar of the draw works housing
