Safety Alert

From the International Association of Drilling Contractors

ALERT 11 - 05

FALL INCIDENT DURING RIG UP RESULTS IN FATAL INJURIES

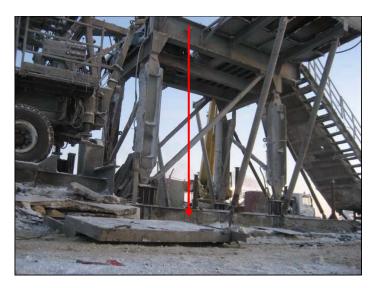
A drilling rig was being re-assembled on a new well location. The driller was working with a crane operator and another drilling rig employee to properly position the doghouse on the rig platform. To ensure the doghouse was in its proper position, the driller laid down on a folding work platform adjacent to the doghouse. The platform had been placed on the rig supports, but was not secured in place. As the driller moved out onto this platform it tilted and fell, causing him to fall 5 meters (16.5 feet) with the platform landing on top of him. The other drilling rig employee immediately summoned help. The platform was removed from on top of the employee and first aid was rendered. Following arrival of the emergency services, the driller was confirmed to have died.

The investigation team determined two key immediate causes for the fall:

- The platform that fell had been placed in position on the rig and left unsecured for a significant amount of time.
- Fall protection/PPE was not used, despite working on a ledge where the risk of a fall was 5 meters (16.5 feet).

- Instructed rig personnel to ensure all tasks performed where there is a risk of falling more than 1.8 meters (5.9 feet) are completed using fall protection/PPE. This must be a "no exception" rule.
- Instructed rig supervisors to ensure appropriate rig supervision are provided at all times to ensure higher risk tasks are performed properly and with the appropriate controls in place to prevent incidents.
- Instructed rig personnel to utilize a rig specialist to check all existing rig structure elements in the Contract Drilling Group to ensure compliance with original manufacturers' design specifications. Out of compliance changes will be identified and corrected through proper engineering design improvements.
- Implemented technical review audits of all rigs to ensure operational compliance to the established global standards.
