Safety Alert

ALERT 11 – 06

NEAR-HIT INCIDENT - DROPPED OBJECT PIPE HANDLING PUSH-ARM FELL TO THE RIG FLOOR

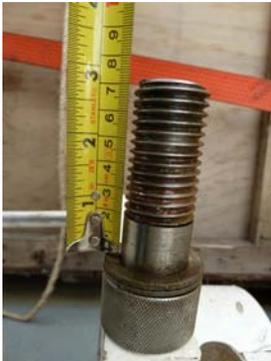
- An investigation revealed that the 882lb arm was held onto the davit by a 1 ½" long bolt. The short bolt did not allow a sufficient number of threads to screw into the support structure.

The amount of thread that held it in its place

- The failed equipment has been removed from service before any further operations were conducted.
- A notice has been sent to the manufacturer to alert them of this incident indicating the reason for failure.

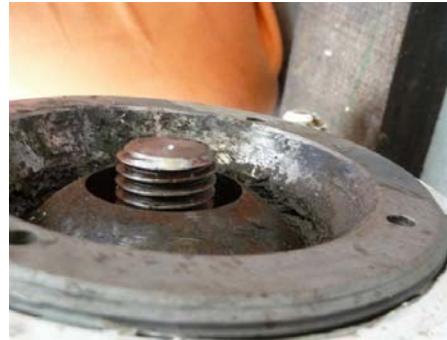
The amount of thread that held it in place

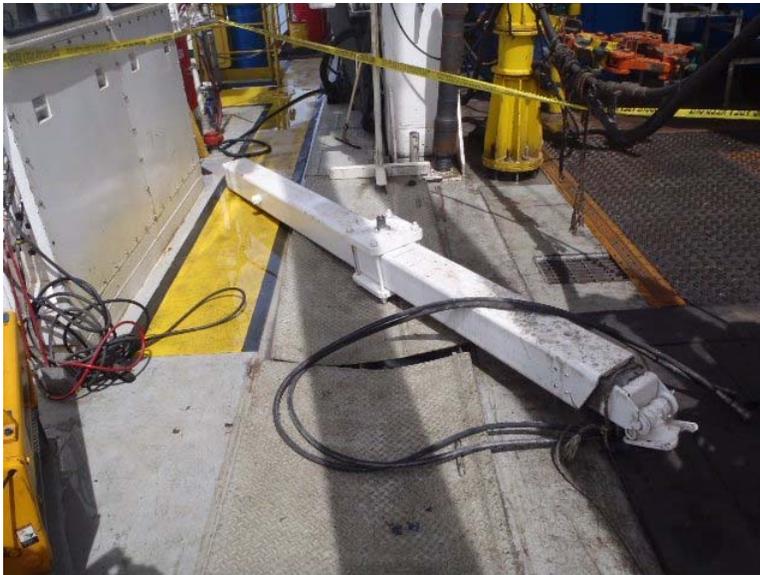
While drilling a 12 ¼" hole, the driller observed the unused Safety Push Arm fall 15 feet (4.5 meters) onto the rig floor just in front of the Driller's cabin. The arm caused dents to the rig floor cover plates. There were five (5) rig floor workers in the vicinity working near the V-Door, but luckily no one was injured and no other equipment was damaged. The piece of equipment that fell measured 12' 6" long and 8" X 8" wide, weighing 882lbs. It had the potential to cause fatalities.

The 882lb arm that fell from the derrick

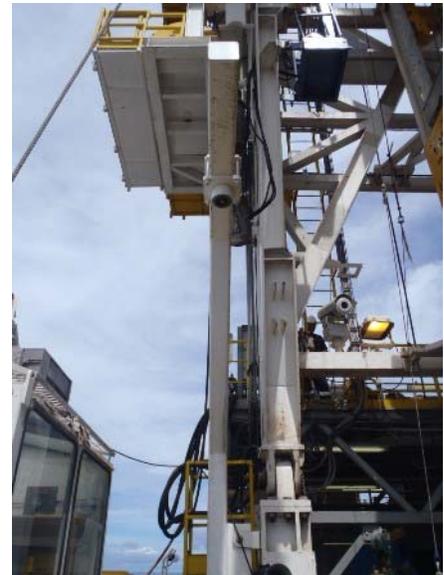
The davit that held the arm
