Safety Alert

From the International Association of Drilling Contractors

ALERT 11 - 07

ADJUSTING THE LINK ASSEMBLY ON PIPE SPINNER RESULTS IN A RESTRICTED WORK CASE (RWC)

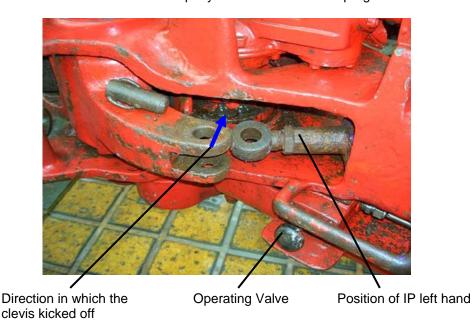
The motorman (Injured Person [IP]) was requested to inspect and adjust the adjustable link assembly on the pipe spinner. The motorman (IP) was lining up the hole on the clevis of the adjustable link assembly with the hole on the operating arm using his left hand. At the same time he turned the air supply back on in order to move the operating arm into position. The IP operated the control valve with his right hand. The pressurized operating arm of the pipe spinner moved forward and contacted with the clevis of the adjustable link assembly. This caused in the clevis link to kick towards the main body of the pipe spinner. The IP's ring finger was caught between the clevis link and the main body of the spinner which resulted in the tip of his ring finger being severed.

- Lack of safety discipline due to no pre-job planning and no JSA being conducted.
- IP did not inform his immediate supervisor of performing the job on the rig floor.
- IP was not aware of the potential risk of his hand position.

- A JSA was created and procedures for this task were generated.
- Re-trained the IP and other crew members in reviewing JSA's and the Step Back 5x5 programs.
- Re-trained the IP and all other maintenance helpers on the importance of implementing the JSA and Permit to Work System.
- Instructed rig personnel that Maintenance Supervisor is to be informed before undertaking any task, so that assistance or instruction can be supplied as needed.
- These instructions will be added to the company JSA and Procedures programs.
