# Safety Alert

From the International Association of Drilling Contractors

ALERT 11 – 21

## NEAR MISS – LACK OF INSPECTION RESULTS IN DROPPED IRON ROUGHNECK

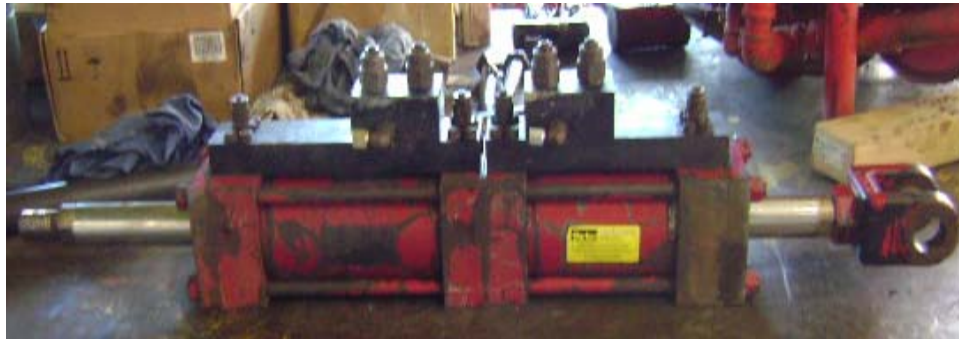
While the Iron Roughneck was extended, the cylinder shaft pulled from the clevis on the extender end of the cylinder. This allowed the extender unit to fall outward onto the rig floor landing against the drill pipe stump. When the extender unit fell, it narrowly missed two employees. Fortunately, no employees were directly between the unit and the drill pipe stump and no injuries resulted from the incident.

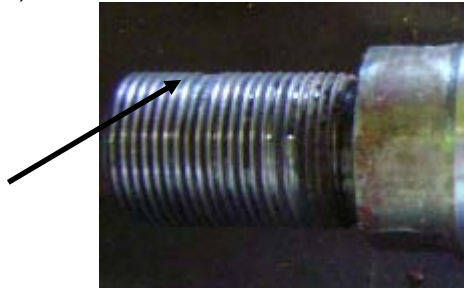
The shaft of the extender is screwed into the clevis. Inspection of the threads revealed that the threads had stripped and pulled from the clevis. The threads appeared to have become galled at some point and the deterioration continued to weaken the contact between the clevis and shaft to the point it could not hold the weight (6900 lbs.) of the extender unit.

Upon inspection of the failed parts, it appeared they may not have been fully tightened against each other at the time of failure. An inspection was conducted of all other Iron Roughnecks in use. The inspection revealed that all shafts and clevises' on the units were fully tightened against each other except one. The extender unit that had a space between the two parts was replaced with a new cylinder, which comes with clevises attached. All the iron roughnecks had been in service approximately three years.

- Instructed designated company mechanics to conduct Bi-annual inspections of the extender units.
- Instructed the mechanics to train rig personnel to perform daily inspections to ensure all shafts and clevis's are snug with no gap between the two and to report any variance.
- Action: Any variance in the condition of the extender unit shaft and clevis which is noted will result in replacement of entire cylinder.

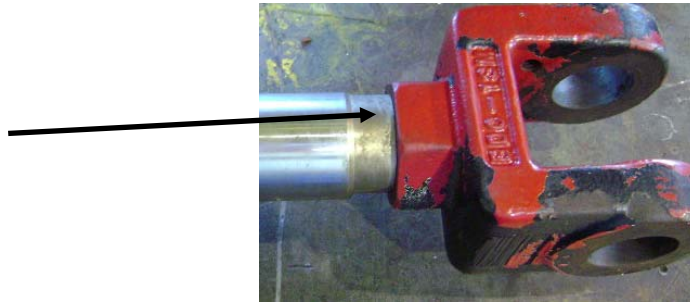
The clevis was removed from the replaced extender cylinder assembly and was taken out of service for inspection and galling of the threads was discovered. This leads to the conclusion that if there is a gap between the shoulder of the shaft and the clevis, there is potential for failure and injury.
