Safety Alert

From the International Association of Drilling Contractors

ALERT 12 – 02

DISREGARD FOR ENERGY ISOLATION PROCEDURES RESULTS IN AMPUTATION

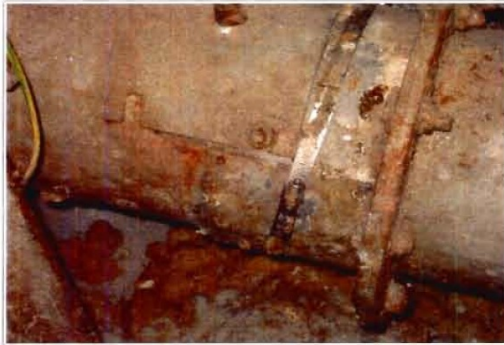
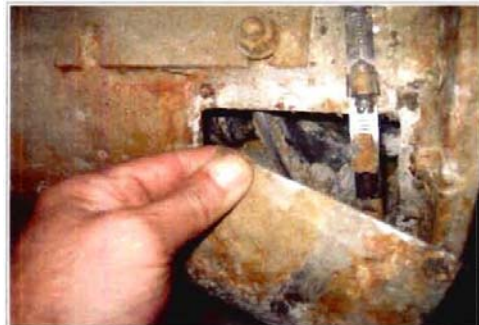
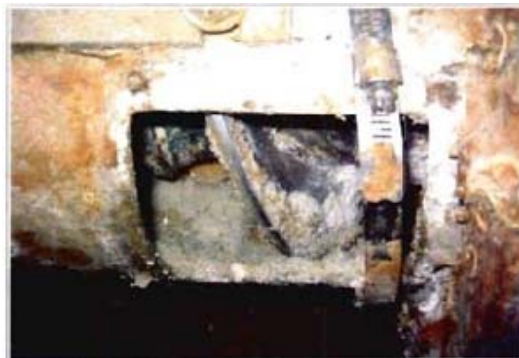
The derrick man was replacing a small hatch cover, which had been removed to clean out the auger on the horizontal conveyor in the sack room. The conveyor had backed up due to chemicals absorbing moisture because of the humidity and heat. The chemicals blocked the operation of the auger and had to be “dug out” from the hatch cover by using a special tool fit for the job. To determine that the auger was free, the auger was engaged and the derrick man observed it through the cleanout opening. Once it was determined that the auger was operating properly, the derrick man decided to put the hatch cover back in place; however, he failed to shut down the auger with the E-stop prior to reinstalling the cover. With the system still running he began to reinstall the cover, which resulted in his left index finger coming in contact with the rotating auger and resulting in his losing the tip of his index finger.

- Improper hand and finger placement when fitting the cover back in place.
- The derrick man did not follow the company permit to work and Lock Out/Tag Out procedures in place for the job.
- The cover did not have a handle for the derrick man to grip and reinstall the cover.
- No JSA or Risk Assessment was conducted for the job because he stated, “we’ve always done it this way.”

- Develop a JSA and risk assessment for this job.
- Place signage at all augers "Work only performed under Permit to Work and Isolation Certificate".
- Place handles on all auger covers to remove and reinstall safely without hands near augers.
