Safety Alert

ALERT 12 – 05

NEAR MISS – TRACK HOE CONTACTS 5 KV POWER CABLE

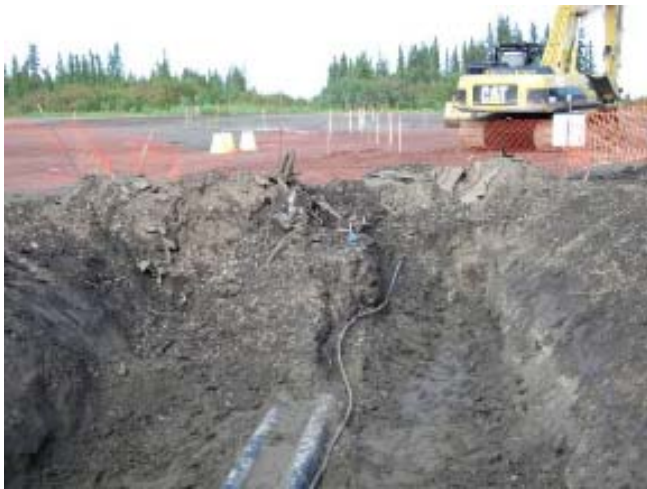
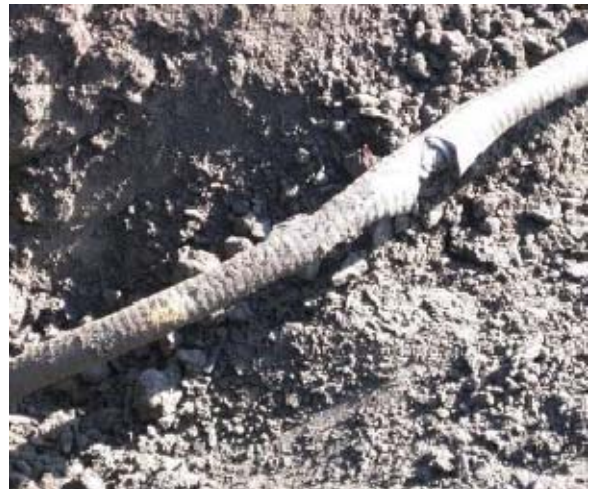
During the mechanical excavation of two 6" pipelines and a power cable, a 5 KV power cable tightened when contact was made with the track hoe bucket. The power cable was discovered through hydro excavation and inspection of the survey drawings indicated that the power cable followed a path adjacent to the pipeline. The contact location was determined to be outside of two foot (2') of the path of the pipeline underneath the backfill. After being contacted with the bucket of the track hoe, the cable shorted when manually moved by the ground disturbance supervisor.

- The power cable was not identified as a significant hazard on the Critical Work Permit or Job Safety Analysis (JSA).

- Identify Work Management Scope Changes: Finding an unexpected power cable while excavating may warrant a work scope change. Once found, work should be stopped and the power cable indicated on the critical work permit or JSA to prompt additional mitigation measures (e.g. De-energize, hydro-excavation);
- Standard for Excavating Power Cables: Develop an explicit procedure for exposing an underground power cable to be included in the procedures for ground disturbance;
- Never approach or touch a power cable after it has been contacted. Contact an electrician to de-energize before inspecting damage.
