Safety Alert

From the International Association of Drilling Contractors

ALERT 12 – 30

UNSTABLE LIFTING DEVICE INJURES CREWMAN

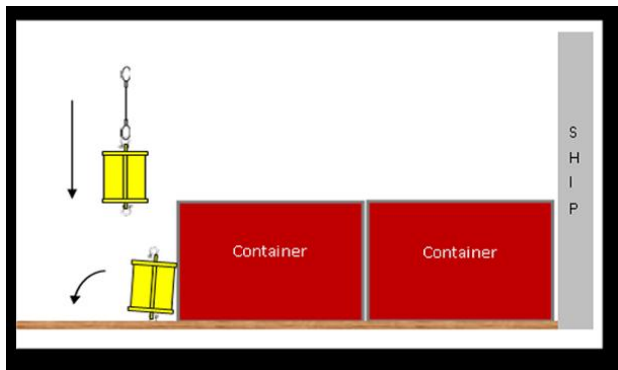
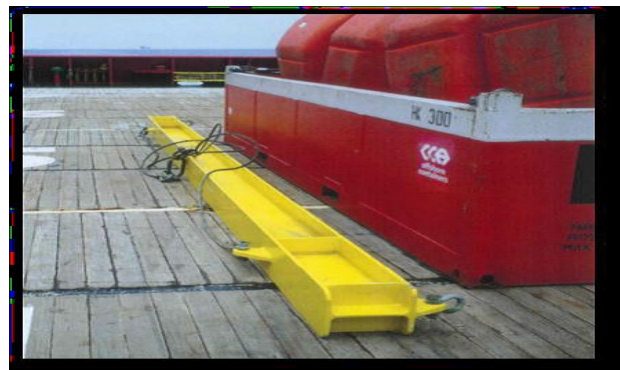
The vessel was about to complete discharging and back loading at the platform. The last lift to come down was an “I” shaped spreader beam which measured approximately 8 meters (26 feet) long. The top and bottom of the beam has two lifting eyes situated at each end. The crane operator lowered and set the beam down on the lifting eyes directly against a previously loaded 20 foot (6 meter) basket. When the tension was taken off of the lifting slings, the two Able Seamen (ABs) moved towards the beam to release the slings from the hook. As soon as the slings were disconnected, both ABs focused their attention on the hook to make sure it would not hit them. At that moment, the ship made a slight rolling movement towards the starboard side and the beam flipped over, landing on top of and fracturing the left ankle of one of the AB's.

- The landing was unstable and the spreader fell on its side due to the beams eyes on the bottom side.
- The weather and position of the vessel was calm. The small movements from the vessel attributed to the beam standing for approx. 30 seconds in the upright position against the container.

- This lifting beam was not considered hazardous cargo (unstable cargo) by all personnel involved and accepted to be loaded on the vessel.
- The AB's were both focused on the hook after the cargo was landed, as they considered the beam stable and did not move a safe distance away from the beam.

- The crew was reminded that every lift must be properly planned (Manifest).
- All members of the lifting team were reminded that there must be clear communication between the deck, bridge and rig.
- It was emphasized to the deck crewmen that more attention should be paid to every lift.
- The deck crew was reminded not to unhook any cargo until it is stabilized on deck.
- The company took steps to ensure good induction and familiarization for new crew members.
