# Safety Alert

ALERT 11 – 14

## HIGH POTENTIAL NEAR MISS - DROPPED OBJECT

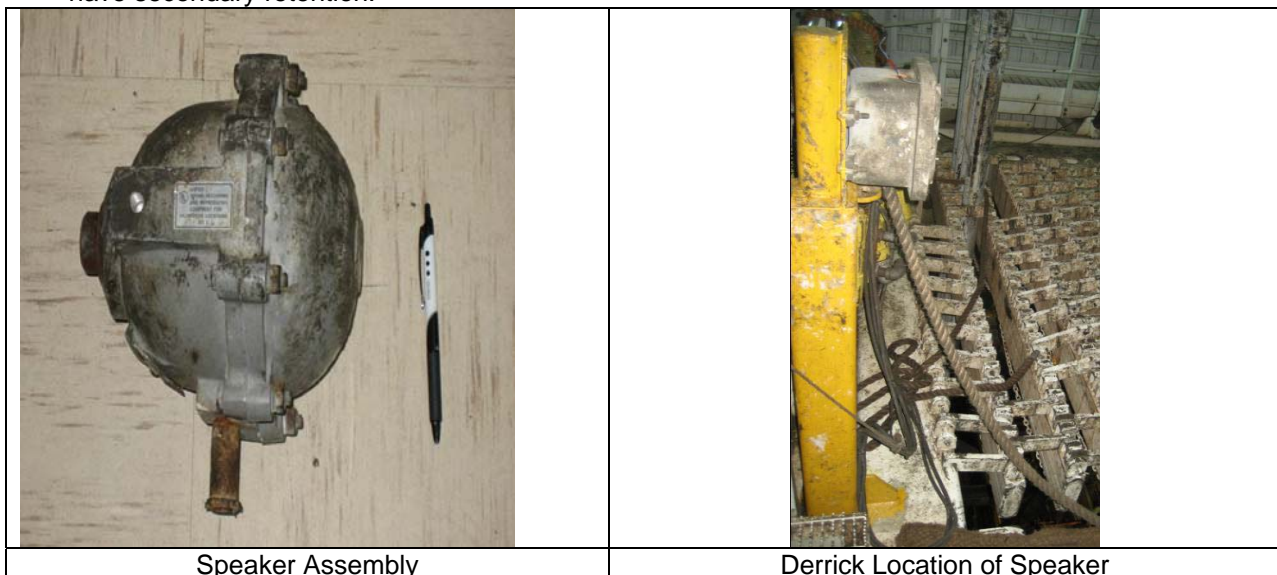
The drill crew was tripping in the hole with 5 ½ inch drill pipe. The derrickman attempted to place a stand of drill pipe in the elevators but missed and the stand was dropped across the derrick. When the stand was being recovered it was pulled back to the fingers, it struck the fingers causing shaking and vibration to the derrick and monkey board. The motion caused a 12 lb. (5.4kg) speaker mounted at the back of the monkey board to break loose at the junction box. The derrickman was standing next to the speaker at the time the stand struck the fingers and was able to catch the speaker as it fell and it was brought down to the rig floor.

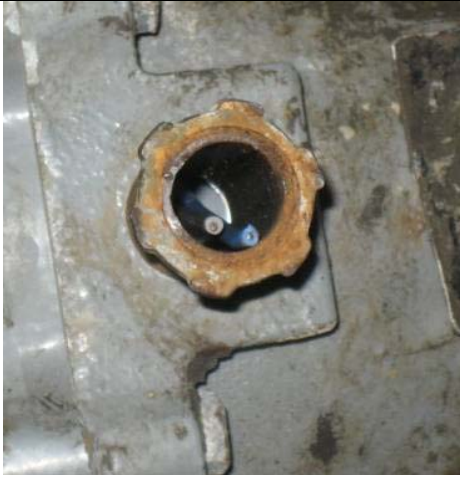
- When speaker was installed in the new derrick it was not secured with secondary retention.
- The unsecured speaker had not been identified by third party derrick inspection as well as rig specific inspections.
- The speaker wire housing / mounting post thread was cracked  $\frac{3}{4}$  of the circumference but could not be seen due to its location which was flush with the junction box.
- The vibrations and shaking of the derrick from the dropped stand retrieval caused the speaker to shear from the junction box.

Clean area-no crack or sign of rust. This is what broke and was all that was holding the speaker in place.

- Immediately perform a full derrick inspection to ensure placement of secondary retention.
- Develop derrick inspection / secondary retention training to cover proper use of secondary retention, hands on / visual inspections, corrosion, hazard identification and temporary and permanent installations in the derrick.
- Conduct a full derrick inspection once derrick inspection / secondary retention training has been completed.
- Amend the “Derrick Access Log” to advise that all temporary or permanent equipment aloft is required to have secondary retention.

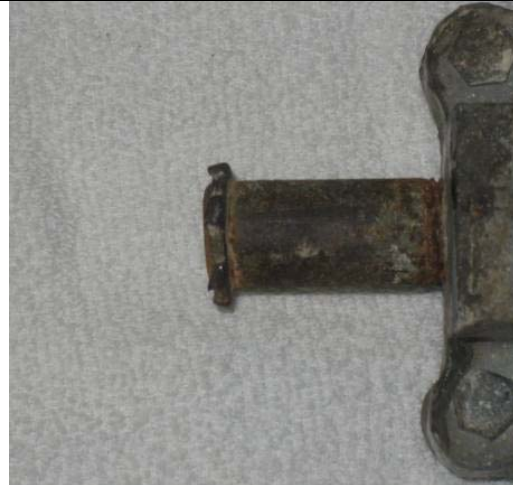
Speaker wire housing / mounting post. This point was flush with the junction box where it broke loose.
