# Safety Alert

From the International Association of Drilling Contractors

**ALERT 07 – 05**

## **INCIDENT INVOLVING THE LINK TILT RESULTS IN A LTI**

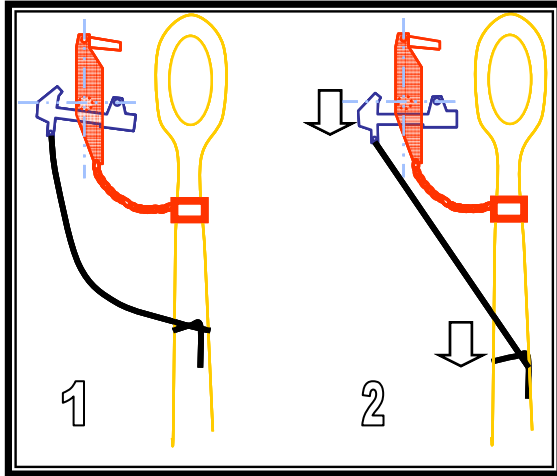
- The Intermediate stop was not in the correct position because a rope tied on the intermediate stop had been fastened to one of the bail arms. The continual action of the link tilt extending and retracting resulted in the rope attached to the bail arm to move downwards. This resulted in the intermediate stop being gradually pulled downwards and out of position.
- Although the driller had begun to retract the link tilt, pressure still remained in the system as it is pneumatically operated. The resultant pressure caused the link tilt to extend with speed and force when the intermediate stop bar passed the intermediate stop.

**Picture 1** Rope attached loosely to the bail arm using a half hitch

**Picture 2** Rope moving down the bail arm causing the intermediate stop to swivel down against the link tilt spring. (The action of the link tilt extending and retracting allowed the knot to slide down the bail arm. The configuration of the knot allowed the rope to move down the bail arm and prevented it from traveling in an upwards motion)

- Remove the rope when it is not required.
- Do not tie the rope to the bail arm at any time.
- Consultation with the manufacturer to seek an engineering solution

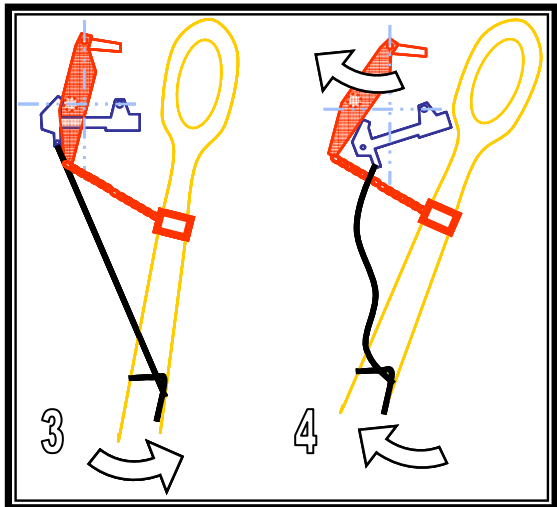
**Picture 3** At the time of the incident the elevators returned to the position of the intermediate stops. The rope on the intermediate stop was pulling down. This resulted in the stops contacting the top of the intermediate stops.

**Picture 4** The action of the elevators returning to position caused either the intermediate stop bar to jump over the intermediate stops or the intermediate stops to travel downwards enough to let the stop bar travel past the intermediate position.
