Safety Alert

ALERT 08 – 11

IMPROPER USE OF ELEVATORS WITH TOP DRIVE ASSEMBLY

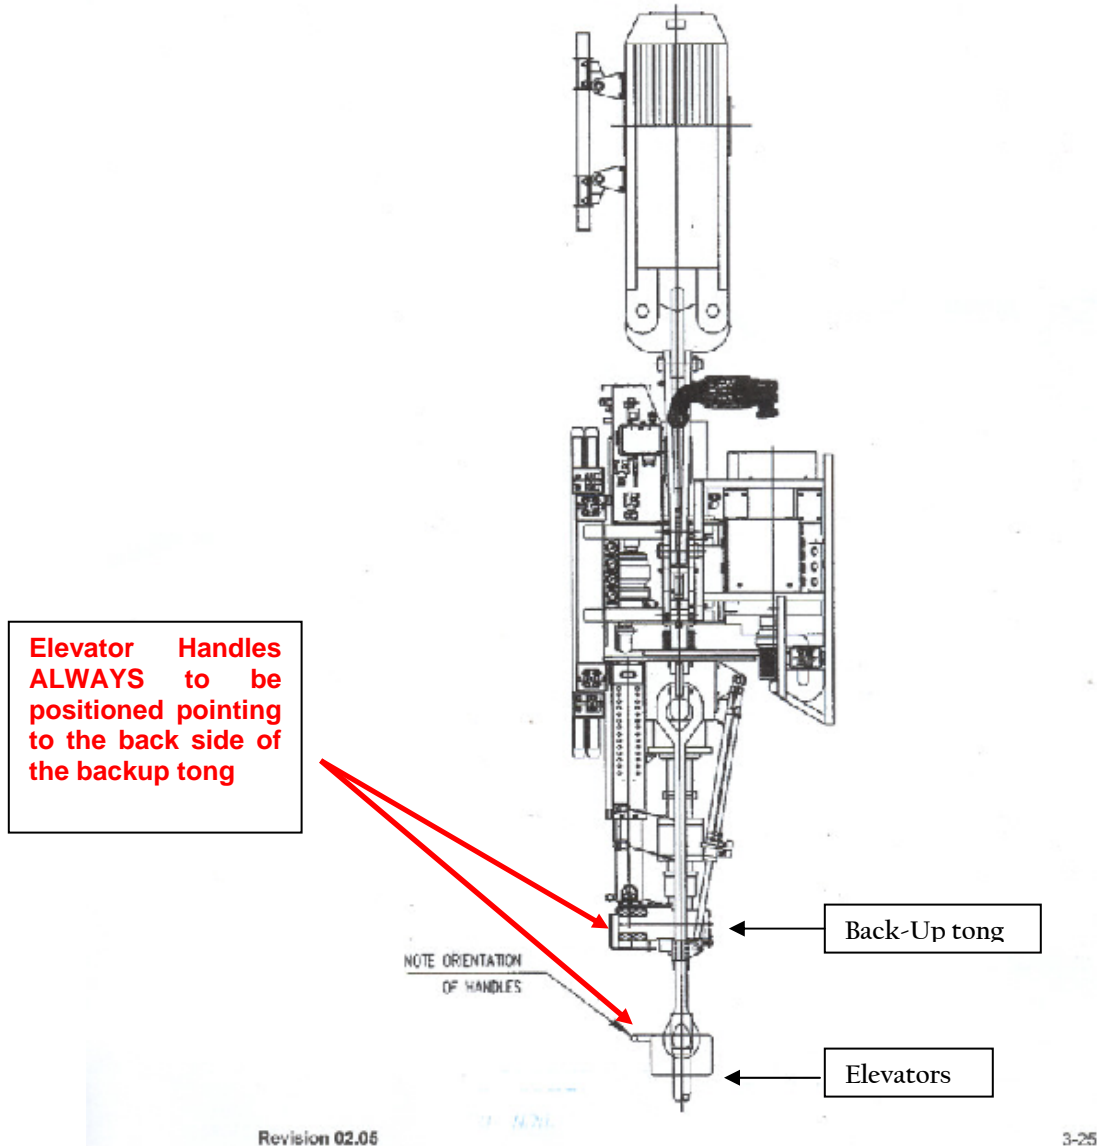
Figure 3.2

Elevator Arrangement
