Safety Alert

From the International Association of Drilling Contractors

ALERT 08 – 12

FALL FROM HEIGHT RESULTS IN LTI

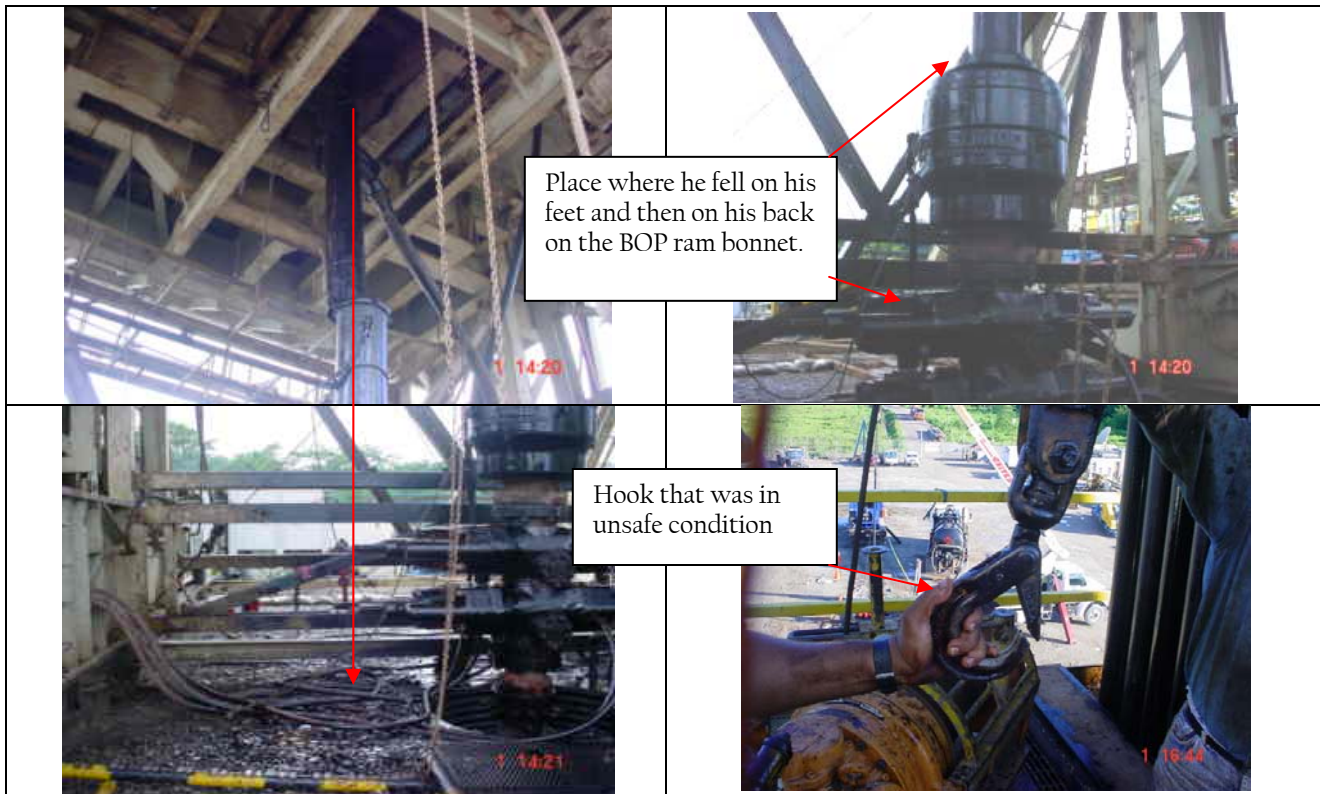
Two roughnecks were working in BOP area to reposition the telescopic bell nipple. After working on the bell nipple, the Supervisor sent the winch line down through the rotary table opening. While the injured person (IP) was standing on the rotary beams he attached himself to the winch line hook and then unhooked his lanyard from the rotary table beams. As he disconnected his lanyard, the chest ring on his fall protection harness slipped out of the winch line hook causing the IP to be without fall protection which resulted in him falling 10-15 feet to the annular then another 15 feet to where he landed on his back over the BOP rams and eventually coming to rest on the ground near BOP hoses. The Rig's Emergency Response Team stabilized the IP and he was transported to a local hospital for evaluation and treatment then transported to a hospital trauma facility. The medical assessment showed multiple fractures of the pelvis and back.

- The crew used a hook which was in unsafe condition.
- Rig did not have in place the self retracting lifelines (SRL) for working at height in substructure/BOP area.
- The winch used was not adequate for the activity. A Man-Rider Winch should have been used as required by standard operating procedure.
- The rig had scaffolding available for working on the BOP, but it was not installed due to nature of work being performed.

- The unsafe hook had been identified earlier, but had not been replaced as per established procedure.
- No JSA or Permit to Work was issued to perform the activity and all potential hazards had not been identified for this task.

Immediate action: Instructed the Rig Manager to change out the unsafe hook as soon as the mast is rigged down.

- Per the company's equipment standard, a request was made to place a dedicated man-rider winch for the rig.
- Rig personnel are to use fall protection as per company standard for personnel hoisting activities.

- Rig personnel installed SRLs below rotary table that are adequate for the job.
- Rig personnel were instructed that scaffolding will be erected when working in BOP area.
