Safety Alert

ALERT 08 - 19

TONG CLEVIS DETACHES RESULTING IN EMPLOYEE INJURY

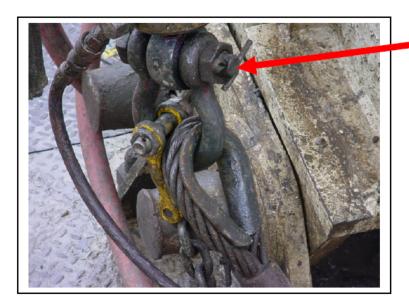
This is the bolt which fell out, the cotter key was replaced after the incident.

- 1. The missing cotter key was replaced with an improper keeper. The replacement keeper was much more susceptible to snagging and was apparently pulled out during the TOH.
- 2. The clevis connections were not thoroughly inspected prior to the trip. Had the nut been tightened the bolt may not have come out, even if the keeper were lost.

- 1. Informed rig personnel that when repairing or replacing missing equipment use the proper parts, not make-shift items.
- 2. Rig Personnel are to visually inspect tongs on a regular basis, especially prior to tripping pipe.
- 3. Rig managers are to ensure this Safety Alert is reviewed with each crew member. A pre-tour safety meeting is a good opportunity to conduct and document the review.
- 4. Rig Managers are to ensure that this Safety Alert should be posted in the top doghouse with a copy filed in the rig Safety Alert book.
