Safety Alert

ALERT 08 - 20

IMPROPER LIFTING PRACTICE (LTI)

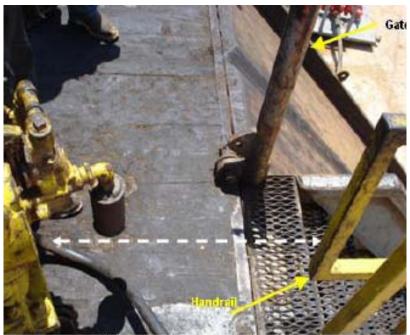
While rigging up the V-door during a rig move, the driller was supervising two floormen who were assigned to install the V-door pins. The crane was holding the V-door in an inclined position and lowering it under the driller's signals. The handrail attached to the V-door steps became stuck against the air hoist on the rig floor (driller did not notice it). The IP was installing the middle pin and another floorman was installing another pin beside him, the driller was helping them and giving signal to the crane operator at the same time to lower the V-door slightly to facilitate the installation of the pin. Suddenly the handrail got free from the air hoist and moved away fast and the V- door gate support hit the injured person's (IP's) left knee. The IP sustained a hematoma in his left knee and put his leg in cast for 2 weeks.

- Inadequate supervision and poor communication, as the driller gave a signal to the crane operator to lower the V-door in, was not observing the load.
- At the same time the IP was still close and installing the pin.
- Driller acted as banksman (signal man) and lift supervisor, thus not giving himself full view of the work place and he failed to see the handrail hung up on the air winch.
- There was a change of design when it was decided to weld the gate support of the V-door. The Management of Change (MOC) process was not followed.
- Welding the V-door gate allowed the hand rail to get tangled with the air hoist on the rig floor.
- The Safe Job Assessment (SJA) did not address the potential of the load getting hung up on the air winch.

Air hoist and hand rail after installation

- Proper SJA to be issued and communicated with rig crews in the pre-job meeting.
- Improve lifting competency of the crew and supervisors.
