Safety Alert

From the International Association of Drilling Contractors

ALERT 08 – 21

INSTALLING ANNULAR BOP RESULTS IN RWC

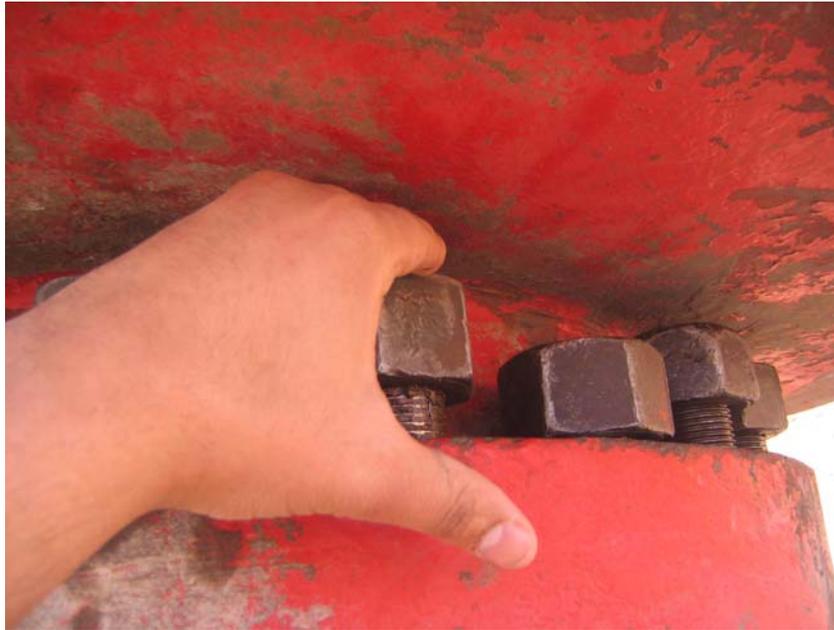
The injured party (IP) was assisting in the installation of the annular preventer to the BOP stack. The annular was being suspended by the crane at the time of the incident. The IP was attempting to get one of the nuts started onto the BOP stud when he inadvertently placed a portion of his hand between the nut and the bottom of the annular preventer. At the same time the annular shifted position and pinched two of the IP's fingers.

The pinch point area between the annular body and the BOP bolt where the IP placed his left hand fingers.

It was determined in the accident investigation that the Annular was being suspended by slings of different length and that the crane boom was not extended far enough to have the load properly centered over the BOP stack. Subsequently, the Annular got caught on one side of the BOP bolts and shifted at precisely the same time the IP had his fingers in the wrong position.

1. The job was immediately stopped and the IP treated for his injuries.
2. A safety meeting was held to communicate incident with all crew members. The JSA was revised and reviewed to include identifiable pinch point.
3. Crew and crane operator were informed to follow safe rigging/lifting procedures.
4. A Safety Bulletin was generated for circulation to other operating rigs.
