# Safety Alert

ALERT 08 – 23

## IMPROPER LIFTING PRACTICE RESULTS IN A (RESTRICTED WORK / TRANSFER CASE)

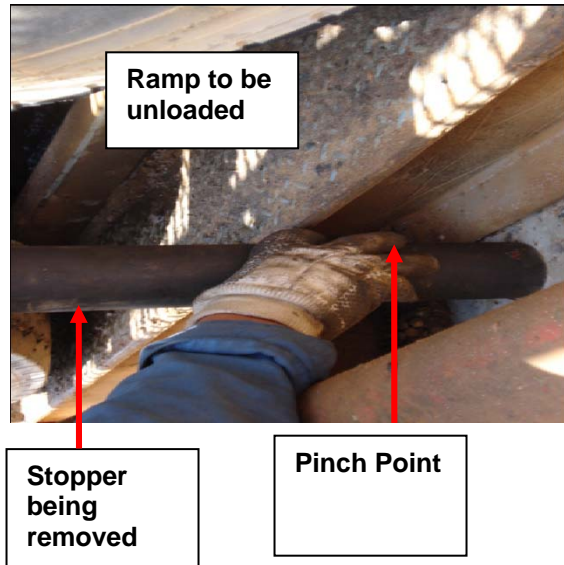
An improper lifting practice resulted in a restricted work/transfer case during a rig move, and while removing the carrier's ramp off the trailer at a new location. The workgroup consisted of a driller (supervisor), a derrick man and a floor man (Injured Person). The forklift was positioned to take off the ramp from the right side of the trailer and the driller was beside it giving signals. To facilitate the lift, two stoppers were removed from the forklift side. The forklift operator tried to lift the load off the trailer but it couldn't lift the load higher than the stoppers installed on the opposite side of the trailer bed. The driller asked the forklift driver to rest the load on the truck and asked the IP to remove the stoppers from the other side, which were in between the ramp and the delivery line (narrow place). The IP went to the other side of the truck where the driller couldn't see him and tried to remove the stoppers. Without checking on the status of the IP, the driller asked the forklift operator to raise the ramp again and didn't notice that the IP had not finished removing the stopper. The IP's left index finger was crushed in between the stopper and the ramp causing a severe cut.

- Poor supervision and communication as the driller did not make sure that the IP had finished the job assigned to him.
- Change of procedure during task.
  - Normal procedure is to lift off the ramp, from the trailer, high enough so that the trailer can pull out from under the load. Then off load the ramp in place.
  - The driller decided to have the IP remove the stoppers on the side opposite the forklift.
  - The injured ended up being in a position where he was not full view of the driller.
  - The driller decided to lift the load again without checking to determine if the injured person had removed the pins and his hands were out of harms way.

- Improve lifting competency of the crew and supervisors.
- Failure to follow Management of Change (MOC).
