Safety Alert From the International Association of Drilling Contractors

ALERT 08 - 26

FALL FROM HEIGHT RESULTS IN DOUBLE MTO

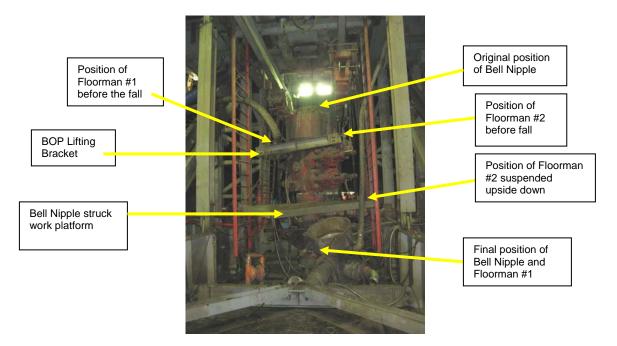
Two Floormen were working in the substructure approximately 4 metres (13.4 feet) above the ground and removing the bell nipple from the top of the blowout preventer (BOP). The flow line had been disconnected from the bell nipple but was still attached to the winch on the drill floor when it was raised unexpectedly. The flow line flange knocked the bell nipple from the BOP seating and it fell to the ground. The Floormen had moved from one side of the Bell Nipple (v-door side) to the other side (draw works side) where they had just connected a soft sling to secure the Bell Nipple. One Floorman (#1 in picture below) had attached his shock absorbing lanyard to the Bell Nipple (approx 300 kg) and he was pulled down and fell to the ground. The other Floorman (#2 in picture below) was knocked off balance and fell backwards to the extent of his shock absorber lanyard before coming to rest suspended upside down with the unused work platform stopping his fall any further. His lanyard did not extend far enough to activate the shock absorber. Both workers were standing on the BOP lifting bracket. Both workers received soft tissue injuries and returned to work the next day.

- The winch line connected to the flow line was supposed to have been disconnected.
- The original plan was to use two winch lines to remove the bell nipple, one through the mouse-hole and one through the rotary table. One line was ready and passed through the mouse hole, but not connected. The Driller changed the plan to use only one winch.
- Neither worker was connected to the Safety Retracting Life (SRL) line fall arrestors which were attached to the underside of the rig floor on each side of the sub base.
- Lanyards used were not secured above head height and in one case the lanyard was connected to an unsecured anchor point (bell nipple).

- All four studs that attach the bell nipple to the BOP annular had been removed before it had been secured with a hoist line.
- No procedure was available for this job.
- No JSA/JHA was used for this task.
- Brief pre-job discussion was inadequate for the task being undertaken and potential risk
- Lack of adequate and / or specific instructions during the task, particularly just before the incident.

- Procedure to be developed with sequential steps particularly the restraining of all equipment before unbolting or removing it.
- Ensure all provided safety devices are used (in this case fall arrestors)
- Processes to be put in place to ensure adequate and thorough Pre Job meetings are planned as part of the job, including the communication of hazards and why controls are necessary to prevent an accident.
- Ensure all instructions given during a job are specific, understood and recorded.
- Outline Supervisor expectations to ensure that jobs are undertaken safely
- Reinforce to the work force that they are empowered to **STOP THE JOB** when safety controls or precautions are bypassed.
- Ensure fall protection lanyard is secured to a suitable (stable) anchor point.
- To reduce fall distance, lanyards are to be secured to anchor points that are above head height.
