Safety Alert From the International Association of Drilling Contractors

ALERT 08 - 39

DROPPED OBJECT: THERMAL TREE CAP (TEA COSY) FALLS RESULTING IN FATALITY

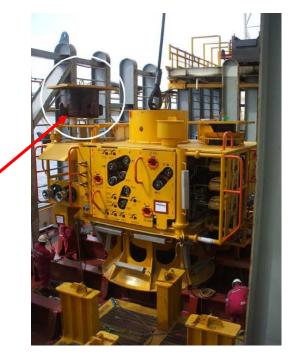
Thermal Tree Cap

The operation was utilizing a rig crane to move a subsea tree from the storage bay to the transport trolley. When the tree was approximately 20 inches (50.8 cm) above the trolley, a crane failure resulted in a non-powered descent of the tree to the trolley. As a result, the unsecured thermal cap was dislodged from its pedestal and fell, fatally striking an employee involved in the task. The thermal cap weighed approximately 980 pounds.

- 1. The thermal cap was unsecured.
- 2. While suspended by the crane there was an uncontrolled descent of the subsea tree which resulted in the unsecured thermal cap being dislodged,
- 3. This uncontrolled descent of the subsea tree occurred due to an over-torque of the crane's motor that operates the main block hoist.

- Subsea Tree Handling and Running Operation Activities:
 - Review, with respective operators and their suppliers, the operator's and their supplier's Dropped Object survey accompanying subsea trees planned to be handled or run on company installations.
- If a Dropped Object survey has not been conducted, it must be completed and reviewed by all parties prior to handling or running any subsea tree.

- Ensure all items identified as potential dropped objects are either removed from the subsea tree (preferred method) or secured in a manner approved by the subsea tree supplier's engineering department to prevent and restrain any potential dropped object.
- The Rig Manager is responsible to review and approve the subsea tree supplier's engineered solution prior to implementing the securing method.
