# Safety Alert

ALERT 09 – 13

## DROPPED DRAWWORKS PLATFORM

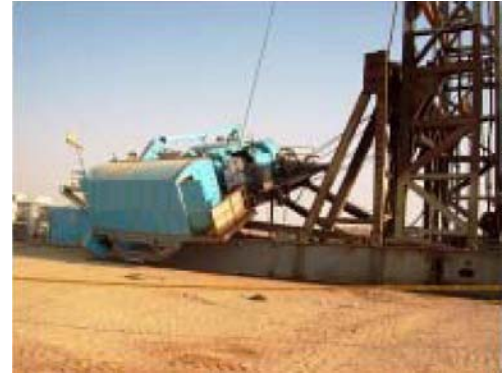
During the process of lowering the draw-works and support structure to the ground, one of two 35 ton sheaves used in the pulley system failed, causing one side of the draw works structure to fall 3 to 4 meters (10 to 13 feet) to the rig sub base. When the structure collapsed, five employees fell, resulting in major injuries (fractured bones and dislocated shoulder) and first aid cases. Potential was for multiple fatalities. The incident also caused major damage to the substructure and draw-works resulting in the rig being unserviceable. A second shackle had been added to the pulley system sheave used to lower the draw-works. This additional shackle caused misalignment of the sheave with the direction of the load. While lowering the platform, the tension in the pulley system increased forcing the sheave plates apart, releasing the sheave pin and resulting in immediate release of the cable and draw-works.

- The rig has been through extensive repair, redesign and recertification by the manufacturer.
- All design issues and the rig documentation were revised by the manufacturer.
- Updated rig move procedures to include details of critical safety tasks.
- Developed lift plans and consider Permit To Work requirements for significant lifts.
- Identified high risk areas during lifting and load movements and removed personnel from these areas during the lifting/loading operation.
- Confirm lifting equipment is certified and that personnel are competent to perform their tasks.

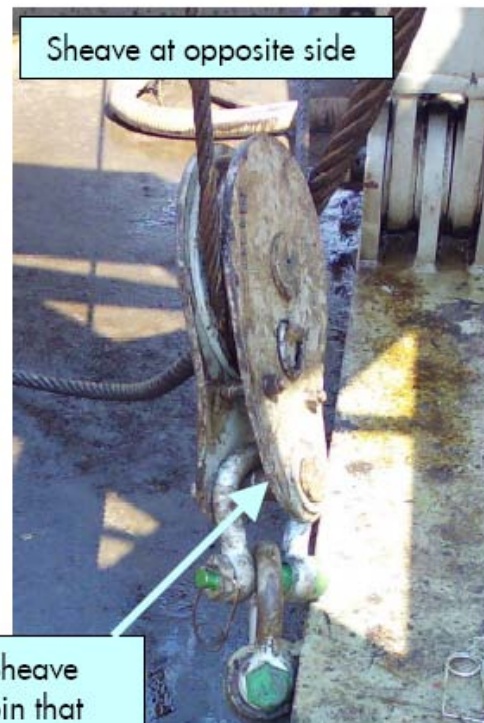
- Personnel were in exposed position during lowering of the draw-works.
- The person in charge had not performed the operation before and procedures did not give detailed and clear guidelines for the rig down operation.
- Although experienced personnel were present they were not listened to and an extra sheave was added to the rigging system.
- There was a failure in the Management of Change (MOC) by altering an existing approved design and the lack of documentation of the rig down procedure to assure consistent performance.
- Person-in-charge handover did not address safety critical tasks.
- Lifting equipment inspection and control procedures were not followed.
