Safety Alert

ALERT 09 – 06

DROPPED OBJECT – RIGGING SCREW JAW END

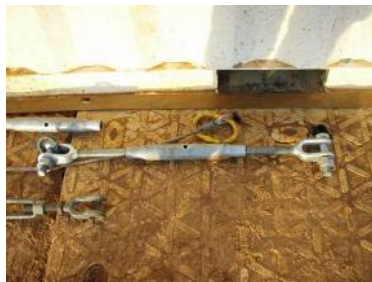
It is important that the terminology used throughout in relation to rigging screws / turnbuckles is understood. The picture to the right shows the two different types. The construction of the rigging screw is such that the thread is enclosed inside a tubular section of steel. The rigging screw is the one at the top and is the type which was carried up the derrick. The turnbuckle pictured at the bottom is the recommended type and has replaced the rigging screw type. Note the turnbuckle used on site is a jaw-jaw type

Improper rigging screw

- Onsite Supervisor is to reinforce "Stopping the Job" is a right and an expected practice.
- Rigging screws have been taken out of service and replaced with OEM recommended turnbuckles.
- The end of the turnbuckle jaw thread has been drilled to allow a safety pin to be fitted. This will act as an extra safety device in addition to already fitted locking nuts.
- Permit-to-Work and Job Safety Analysis awareness sessions were held with all onsite crews.

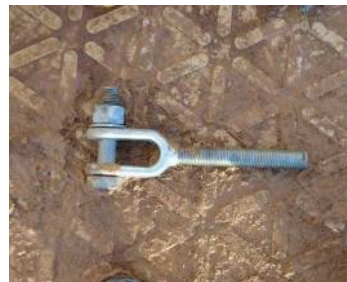
Dropped Jaw End

- Both rigging screws and turnbuckles are normally referred to as “turnbuckles”. Original equipment manufacturer (OEM) drawings call for turnbuckles to be fitted.
- The design of the rigging screw is such makes it hard to determine how far the jaw threads are screwed in.
- Jaw ends of the rigging screws are not fitted with any secondary securing device (i.e. locking nut) to prevent them from backing out. Turnbuckles are fitted with locking nuts.
- Before sending the workers up the derrick the Assistant Driller screwed in both ends of the rigging screw a few turns. Given that one end screws “clockwise” and the other “counter-clockwise” it is possible that he may have actually backed one end out some turns instead of in. This would not be noticeable within the tubular section.

- Rigging screws were new and easy to screw in and out. Given the position of the rigging screw during climbing it is considered possible that with every ladder rung climbed the person's right thigh may have been knocking the bottom jaw causing it to turn and back out.
- Even though this was a non-routine job, no Permit-to-Work or Job Safety Analysis was in place for the task.
- The second person to climb said that he had performed this task before and knew they were not using the correct turnbuckle type. He did not stop the job or question his supervisor because quote "he is the expert and he must know" unquote.
- Failure to **STOP THE JOB**. The employee, who had done the job before and realized that the incorrect turnbuckle was being used, did not intervene.

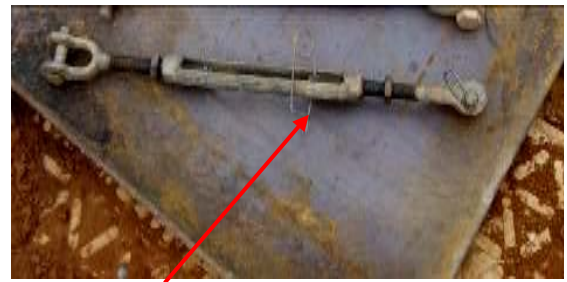
Safety pin fitted to inside thread end
