# Safety Alert

ALERT 10 – 15

## LIFEBOAT PROPERTY DAMAGE INCIDENT

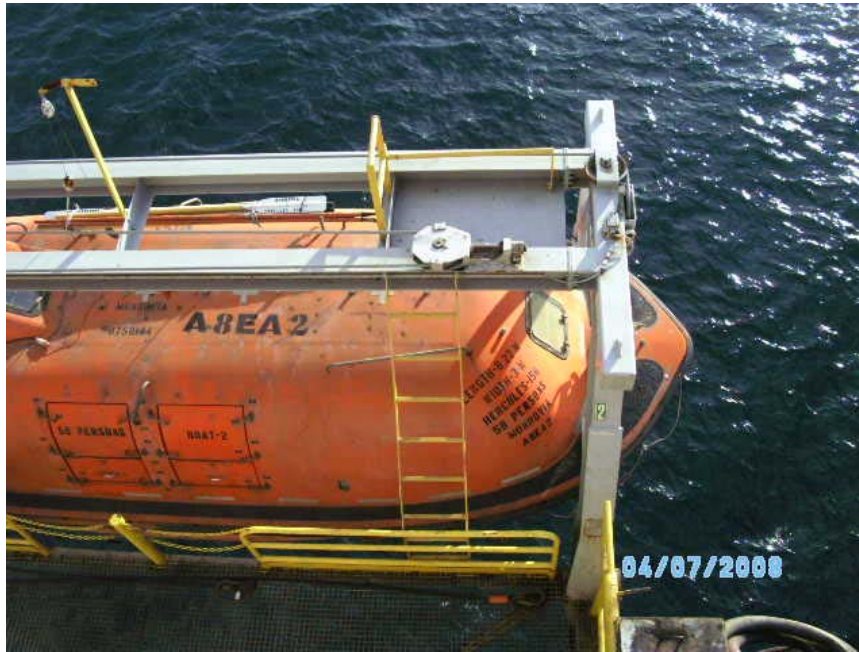
**Equipment Failure:** Lifeboat arrangements with two davit falls/wires and two hooks all have an adjusting sheave located at the top of the davit to allow adjustment so the lifeboat will fit securely against the davit bumper. Photos attached to this bulletin page 2 of 2. The first photo shows an open type adjusting sheave and the second photo shows an adjusting sheave enclosed in a capture or preventer box.

View of open type adjusting sheave without housing that will not catch/hold sheave in the event of failure.

- Open type adjusting sheaves will be fitted with capture/preventer housing.
- Tensioning bolts and nuts shall be compatible and made of carbon steel, not stainless steel.
- Preventative Maintenance will be implemented to require inspection for corrosion or other damage.
- A standard sheave tensioning bolt/nut arrangement.

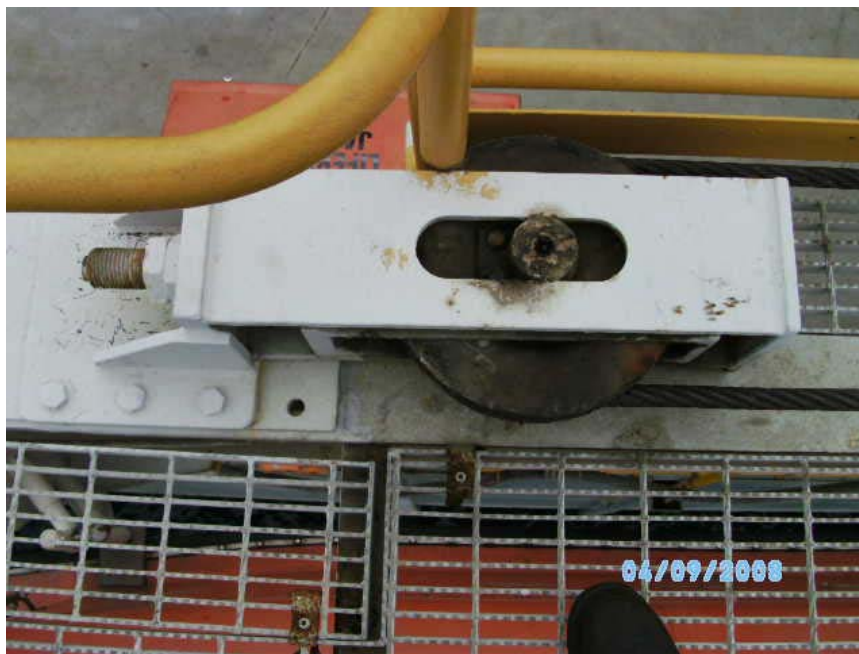
View of adjusting sheave with housing designed to catch/hold sheave in the event failure. Engineering will assist Operations with upgrading open sheaves to this enclosed type.
