# Safety Alert

ALERT 10 – 20

## DAMAGE TO STARBOARD FLARE BOOM

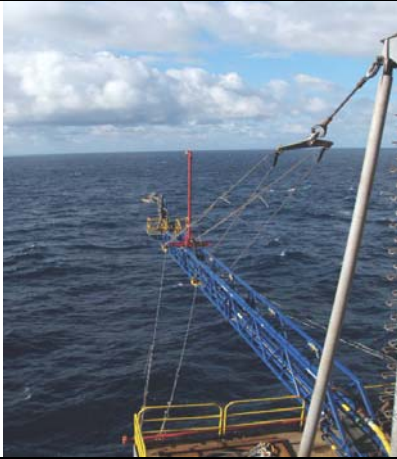
**Starboard Boom Prior to Failure**

The starboard flare boom began rotating slightly on its longitudinal axis and was re-tensioned, which rectified the problem. The starboard flare boom was left extended for approximately 64 hours before hydrocarbons were flared utilizing the starboard burner head for approximately 15 minutes.

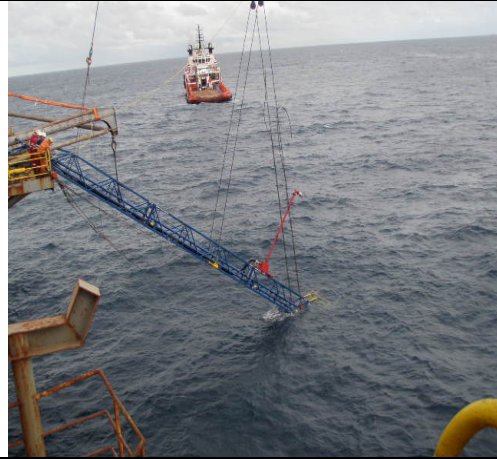
**Starboard Boom After Failure**

After approximately three hours crew members heard a bang from the starboard side of the rig and went to investigate. As a crew member made his way along the starboard side of the rig he noticed that the starboard flare boom burner head was submerged in the water, while the base was still attached to the wing deck with the king post lying almost horizontal above the boom.

A detailed incident investigation revealed that the failure of the starboard king post rear stay base plate was a result of two primary failure modes:

- Incorrect engineering.
- Incorrect welding specification.

Review the design criteria for attaching base plates to the deck structure with particular focus on the design principles (including welding) with regard to uniform deck loading and the potential for hard points to be created by under deck stiffening and the effect these can have on the deck loading.

Review the calculations and loading on connecting pins associated with king post structures.

Review the design criteria for attaching base plates to the deck structure with particular focus on the weld design in regards to the possible effects of Lamellar Cracking relative to the thickness of the deck plate and base plate.
