# Safety Alert

From the International Association of Drilling Contractors

ALERT 10 – 30

## HIGH POTENTIAL DROPPED OBJECT INCIDENTS RESULT IN TWO LTIs

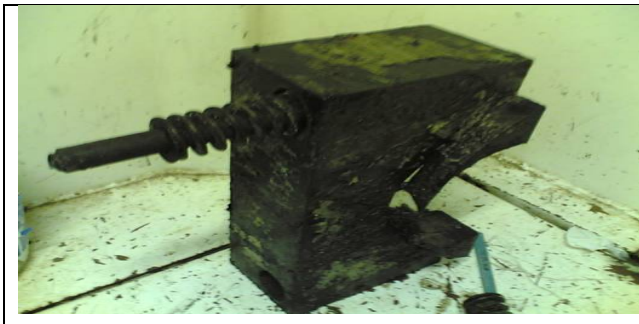
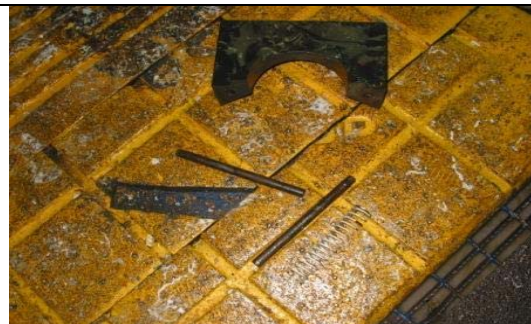
Two lost time incidents occurred on two separate occasions where two employees were struck by falling rubber guides from the Top Drive Back Up Wrenches (BUW).

In both of these incidents it was noted that there was a failure by the crew to identify that the BUWs were positioned improperly. Poor communications occurred between drillers and derrickmen in each incident. The Top Drive must not be set down on the pipe. The torque boost was improperly used to break a connection as stated in the first incident. The BUW cylinder adjustment pins require proper calibration to avoid grabbing the crossover sub. The JSA was not adequate in identifying such hazards.

- The driller is responsible in his operation to see that the Top Drive is not set down on the pipe.
- The driller needs to make sure the BUW is aligned in the center to the pipe as the TD is lowered.
- The driller needs to make sure that the monkey board cameras are operable and used.
- Additional training may be required for the Driller to understand the operation of breaking out drill pipe from the Top Drive.
- There is simply no substitute for good communication between the driller and the derrickman.
