# Safety Alert

ALERT 10 – 34

## FATALITY OCCURS DURING OFFLINE CEMENTING OPERATIONS

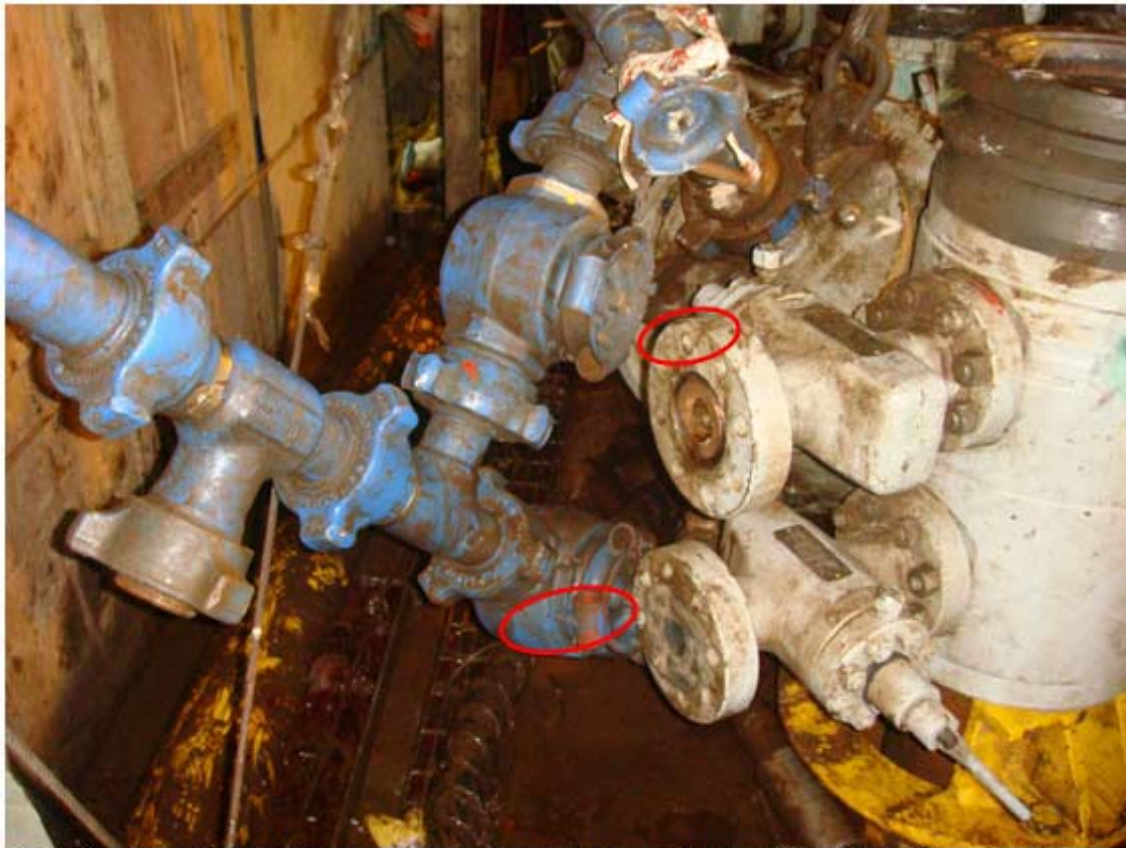
While waiting for the cementing supervisor, the WHE met with the Assistant Driller (AD), who was the supervisor responsible for assisting both Service Companies with the manpower and lifting capabilities for rigging down the cement head / bonnet and installation of Xmas tree. They went through the WHE’s JSA and then proceeded to the production deck and the well head in question. Prior to the arrival of the cementing supervisor and prior to conducting the pre-job meeting, the locking nuts from the cement bonnet were all released. There was no check and the personnel did not recognize that it was under pressure. As the last locking nut was loosened, the bonnet and cement head released from the well (pushed upwards) and toppled towards the AD, pinning him between the annulus valve on an adjacent well and the cement head. The AD was severely injured and passed away shortly after.

Photo 1 – approximate Crush points between annulus valve and valve (1) on cement head

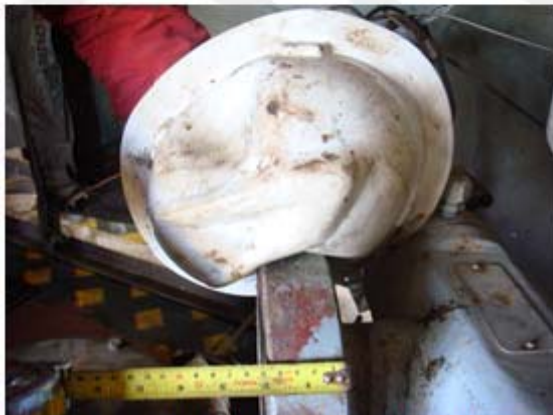
Photo 2 Position of head during impact

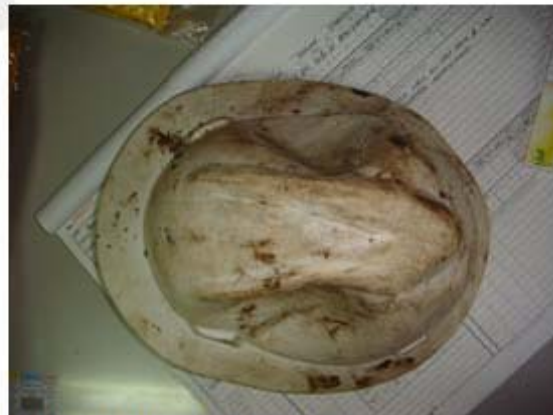
Photo 3 damage to Hard Hat
