Safety Alert

From the International Association of Drilling Contractors

ALERT 05 – 20

MASTER BUSHINGS SET ON IP'S TOE - LTI

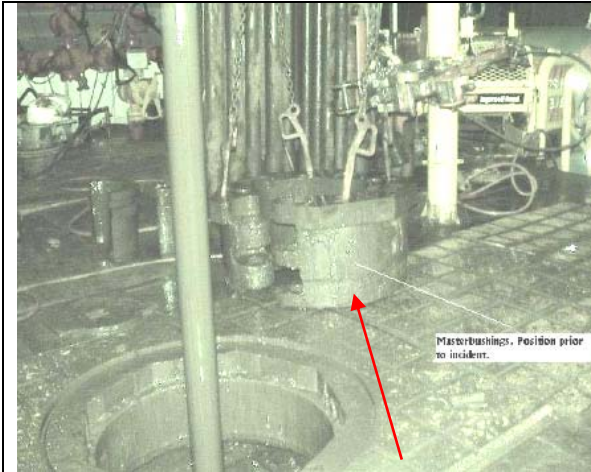
Position of Bushings Prior to Incident

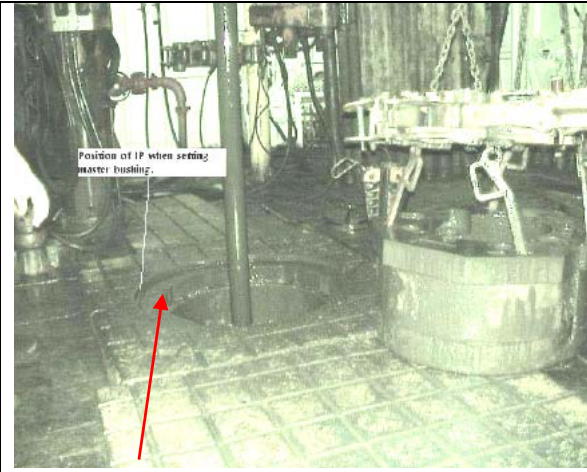
- Lack of awareness regarding the excess mud and slip potential
- Incorrect foot placement and not using the non-skid rotary mat
- Failure to consider and remove excess drilling fluid around the table
- No JRA was ever written for master bushing handling
- Possible self imposed time pressure to complete this task quickly
- Insufficient personnel available to safely accomplish the task
- Possible end of tour fatigue / complacency
- Inadequate number of personnel for the job
- IP's feet not in tugger operator's line of sight
- Pulling bushings rather than pushing (body position)

Position of Injured Person's Foot

OIM/PIC (Toolpusher) to review at the next Crew Weekly Safety/Environmental meeting. Rig Safety / Environmental Committee to communicate to all crew members. Post a copy of this bulletin on the Rig Information Center Board.
