**Safety Alert** From the International Association of Drilling Contractors

ALERT 06 - 03

## HIGH POTENTIAL NEAR MISS/DROPPED LIFTING SUB

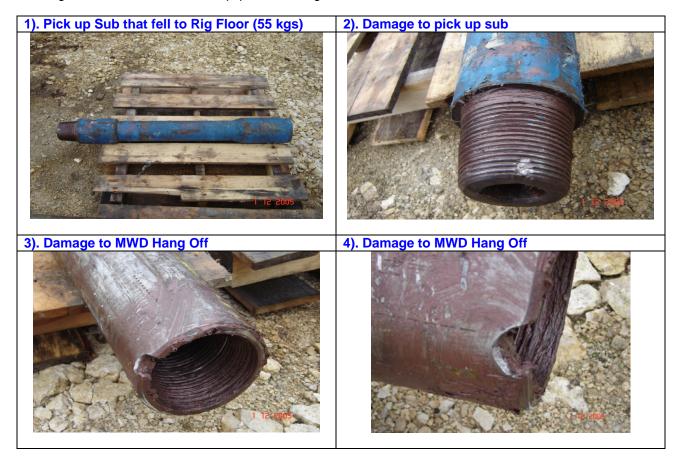
When the driller broke out the lifting sub used to help make up bottom hole assembly (BHA), he hoisted it up approximately 20' to allow the insertion of the Measurement While Drilling (MWD) probe. This activity took about ten minutes. After completion the driller, forgetting the lifting sub was still suspended by elevators, lined them up on the next stand. Since he had a restricted line of sight, he did not see the lift sub before opening the elevators to grab the next stand. This resulted in the sub falling 20 plus feet to the rig floor, causing a serious near miss and equipment damage.

- Failure to follow plan by not laying the lift sub down before inserting probe.
- Not taking the time to ensure clear line of sight or establishing a signaler.
- Driller was not familiar with this particular operation.
- No formal JSA was conducted that included input and responsibility from 3<sup>RD</sup> party contractor.

### Photo showing lay out of incident scene.

Driller	Floor Hand
Pipe in Derrick	Pipe in Derrick
MWD Hand	Floor hand
Position of chip in MWD Tool	Final resting place of Sub
The Corrective Actions stated in this ale and do not necessarily reflect th	│  │ ert are one company's attempts to address the incident, ne position of IADC or the IADC HSE Committee.

- Always ensure a JSA is properly done when working with 3<sup>rd</sup> party personnel and/or equipment. This is the tour pusher's responsibility.
- Never consider any task as routine. Conditions always change.
- Always follow the basic rule of not suspending loads over workers.
- Utilize the STOP by calling time out until communications, by line of sight or with assistance, can be established.
