Safety Alert

ALERT 01 – 42

ENERGY ISOLATION – Top Drive Repair Traps Fingers

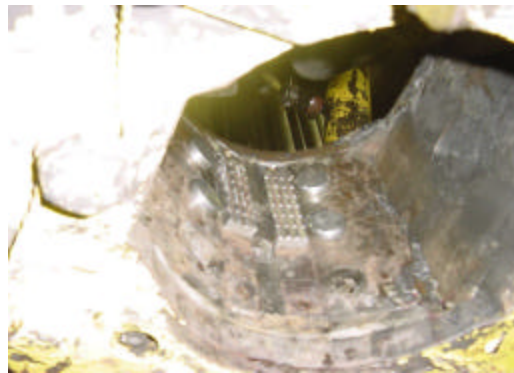
Grabber Head

While tripping in the hole, a keeper pin to the grabber heads was on the rig floor. During the keeper pin replacement, it was decided to replace the grabber heads and preparations were made to access the heads. While removing the heads from the barrel of the grabber, the retractor piston unexpectedly moved from stored energy, trapping the floorman's hands between one of the heads and the grabber barrel severing one finger, two finger tips and badly crushed another finger.

- A pre-job safety meeting was not conducted.
- Energy isolation was not done after cycling the grabber and prior to removing the heads.

- Pre-job safety meetings and Energy Isolation Policy were re-emphasized.
- To bleed off pressure and for easy access to determine that no pressure was in the line, a valve and gauge were installed on the air system to the grabber head piston.
- The procedure for replacing grabber heads was revised to include adequate hazard mitigation and energy isolation.
