ALERT 01 – 43

NEAR MISS – PRESSURIZATION OF A TOTE TANK

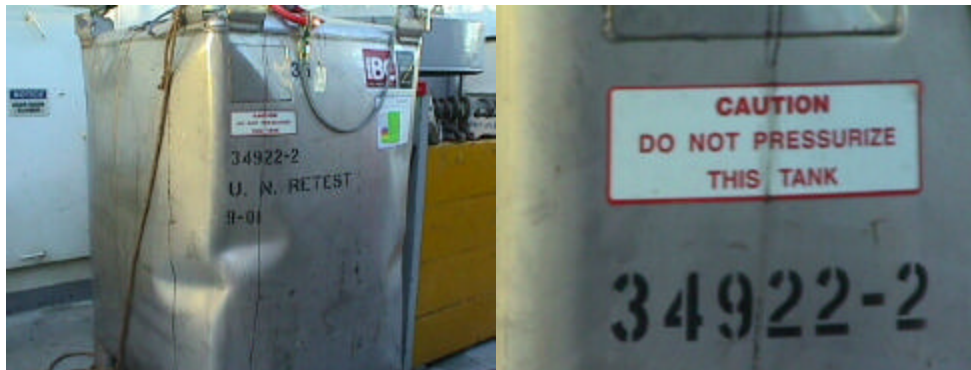
Recently a near miss occurred while a derrick-man and mud engineer was trying to drain a tote of additive into a mud pit. Several attempts were made to drain the tank but due to the consistency of the fluid these attempts failed. The 2" vent on top of the tank was opened and a water hose was attached with a crow foot connection. The 2" drain valve was opened at the bottom of the tank. The tank drained for a short time, then the drain valve apparently became clogged with the fluid. There was no other vent on this tank open and this caused the water to pressurize the tank. The tank was not rated for pressure so when the rig's drill water (approximately 80psi) was stopped from escaping it buckled the tank.

- There was no JSA written for this procedure.
- The proper procedure was not followed for draining this type of tank.
- The proper equipment was not being used for this procedure.
- The failure to recognize the potential hazards involved with this procedure.
- The failure to recognize the potential of the water to be a source for energy.

- A JSA was written on this procedure and the potential hazards were identified.
- An alternate method of getting the product to drain was put in place.
- The importance of hazard recognition was discussed with all personnel.
- The importance of writing a JSA to identify hazards at all steps of a job was discussed.
