# Safety Alert

From the International Association of Drilling Contractors

ALERT 03 – 19

## LIFTING EYE FAILURE RESULTS IN DROPPED PUMP

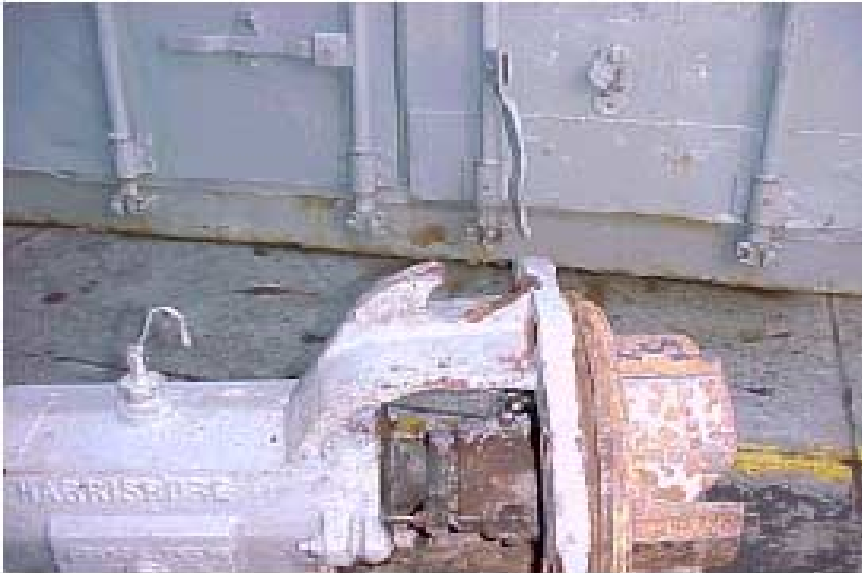
While a centrifugal pump pedestal was being transferred with the crane from the starboard side main deck to the mechanic shop, the integral-lifting eye forged into the pump housing failed. The pump fell on top of the gravel pack screens that were on the port pipe rack, ready to be run into the well bore. The lift was well within the SWL for the sling / shackles. Tag lines were being used to assist with controlling the load movement. All personnel were well away (20 feet) from where the pump fell and struck the tubulars. There were no injuries to any personnel. Five gravel pack screens were damaged.

- Potential failure of the lifting eye was not identified.
- The housing of the centrifugal pump had a fresh coat of paint, which covered any possible crack indicators that may have been present.

**Location of Integral Lifting Eye Failure**

- Do not use individual eyebolts for lifting coupled equipment. Eye bolts and the threaded holes for them are normally meant to lift that individual component only, not an assembled unit or coupled components. Lifting eyes that are built into or integral to cast iron housings are always susceptible to crack failure from impact. The cast components should be checked by dye penetrant prior to lifting the equipment. Care should be taken with all lifts and avoidance of personnel and equipment considered when a lift is made.

- Perform onboard dye penetrant inspection of all equipment that has dedicated lift points prior to commencing operations, which includes moving equipment with integral lifting points.
