Safety Alert

From the International Association of Drilling Contractors

ALERT 04 – 03

IMPROPER SLINGING RESULTS IN A FATALITY AND TWO LTIs

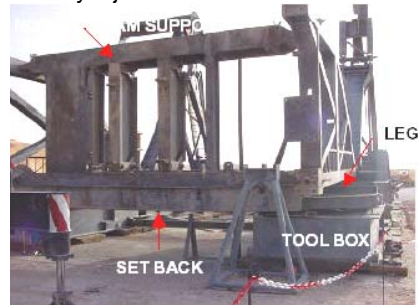
Using a crane the mast was lifted and attached to the rotary beam support and side legs. It was then lowered and pinned to the set back assembly. The assistant driller decided to vary from previous lift procedures and had the assembly lifted so that they could gain access to bolts that were in the toolbox located in the off driller side of the substructure base. While lifting the assembled section, the chains broke. The Assistant Driller and Floorman were working under the load and the second Floorman was kneeling on top of the beam with his fall protection on. Two Floormen sustained injuries and were treated in the hospital, but the Assistant driller was

critically injured to head and died on the way to the hospital.

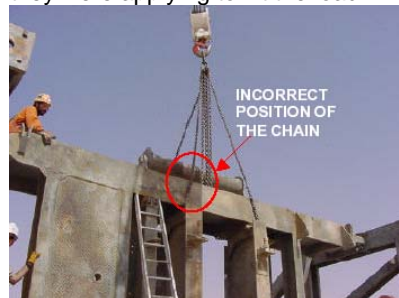
In the pre-tour meeting, the Senior Toolpusher instructed the relief crew to work on other projects and not to work on the mast assembly. The relief crew works under the direct supervision of the Tour Pusher, who had not arrived on the site due to travel delays. The Crane Operator arrived after the meeting and was not aware of the instructions given to the relief crew. Rigging used to raise the mast and install the rotary beam support legs was not readjusted for hoisting the set back assembly. In addition, the sling assembly was rated for 21.4 tons and the load was 23 tons. The Assistant Driller and the two Floormen were under the radius of the load and the third Floorman was standing on the load. The Crane Operator lifted the load without warning the crew to leave the working radius of the crane. The Crane Operator did not assess the lifting risk before raising the section with the set back pinned and he did not check

the lifting accessories. According to procedures, lifting all sections together was never done before.

The Assistant Driller did not consider the chains unfit for purpose. Two Floormen failed to stop an unsafe act. Workers involved did not recognize the incorrect rigging they were applying to lift the load.

- Developed and implemented a detailed Lifting Management Plan for mast sub frame assembly. Review lifting arrangements for rotary table support frame.

- Clarified roles and responsibilities in lifting operations (Crane operators, Tour Pusher and relief crew) and consider dedicated rigger/operator for lifting operations.

- Revised lifting gear management plan for drill site and prepared a daily checklist for mobile crane on the drilling site.
- Established a baseline competency profile for crane operators and riggers and assess them against it. The base line competency may include additional training and replacement to rectify any gaps.
