Safety Alert

From the International Association of Drilling Contractors

ALERT 04 – 16

PLASTIC COATED WIRE ROPE SLING SEPARATED AT SWAGE

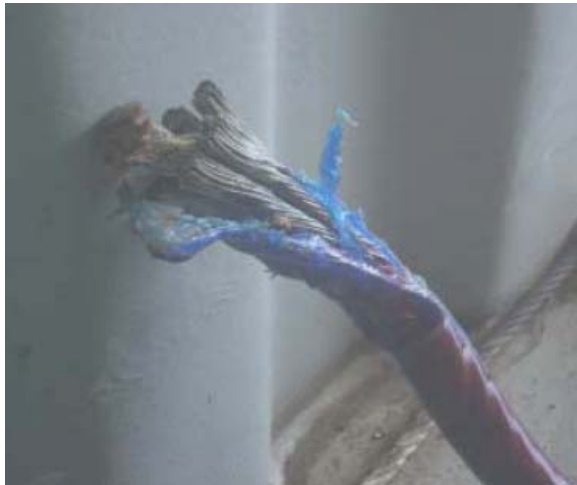
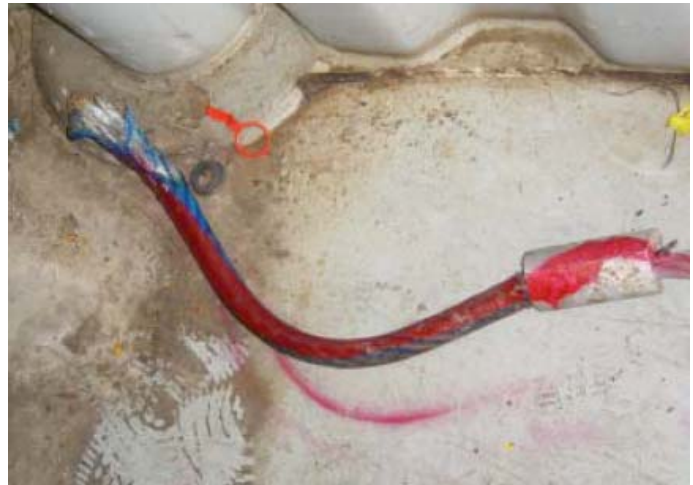
While positioning the stack test cap, the attached sling separated at the swage. The eye of the sling was coated with plastic and crimped into the swage. This sling had been included in a lifting survey completed in June 2003. The sling was rated for 5 tons and parted at 2 tons. Due to the load being controlled, rather than a free load, the cap was unable to fall any distance and no injuries were sustained.

- Eye of sling was coated with plastic including the area crimped into the swage.
- The plastic coating increases moisture and accelerates corrosion.
- The plastic coating inhibits the visual inspection for corrosion.
- Plastic coating inhibits proper gripping of the cable by the swage

IADC Note: Sling manufacturers recommend that all plastic coating be removed from under the swage before it is crimped. Plastic coating decreases the coefficient of friction required for making a swaged sling.

Instructed personnel to remove from service any plastic coated wire slings where inspection indicates that plastic coating is included in the crimped area of the swage.
