Safety Alert

From the International Association of Drilling Contractors

ALERT 04 – 28

SIDE DOOR ELEVATOR INCIDENTS

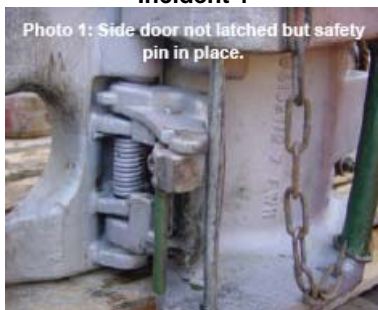
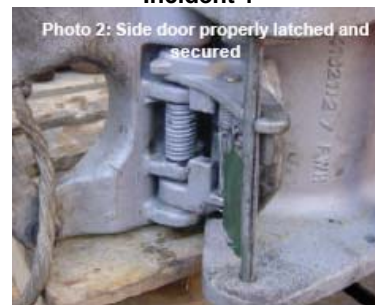
Incident 1

First incident: Recently during casing pulling operations the side door elevator opened while laying out a joint of 7" casing with the crane. This resulted in the joint dropping from the rig floor down against the gate of the V-Door and the leg of the pick-up & lay-down unit, coming to rest on the ground.

Failure by the rig crew to ensure that the latch was fully engaged prior to inserting the safety pin. The safety pin was in the correct hole, however it had been installed at the wrong side of the latch handle (see picture 1)

- 1) Contact the elevator manufacturer in order to modify the existing design in order to further enhance the safety of the tools.
- 2) Until modifications are carried out notify all crew personnel to ensure that the latch is fully engaged before inserting the safety pin.
- 3) Place warning stickers on the elevators.

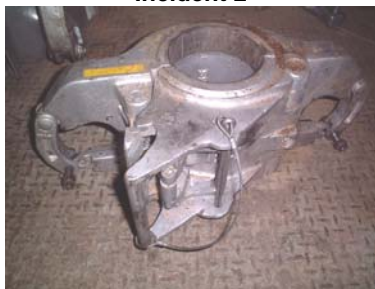
Incident 2

Second incident: During completion tubular running operations on the drill floor, the side door elevators opened while picking up a single joint out of the mouse hole. The elevators opened at the point where the single joint was almost completely out of the mouse hole. The joint dropped across the floor and came to rest with the box end across the TDS frame and the pin stuck inside the top of the mouse hole. Personnel were standing clear at this moment to enable the joint to travel towards the top of the completion already inside the hole. Nobody was injured and the incident.

The safety pin is in, but elevators can be opened by twist.

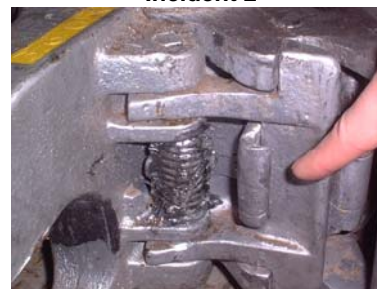
Incident 2

How they should be latched.
