Safety Alert

ALERT 04 – 34

H₂S INHALATION: MAN FELL FROM TOTE TANK RESULTING IN AN LTI

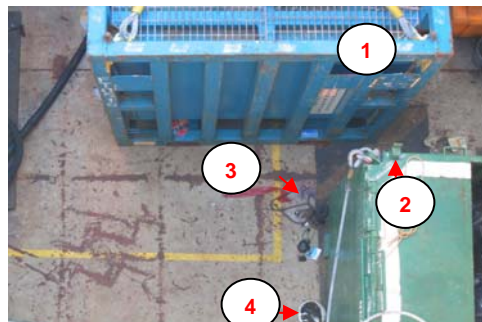
The injured person (IP) was pumping fluid waste contents from the hazardous drain tank to the tote tank on deck. Approximately 40 seconds after the fluid had been flowing, the IP called the Engine Room Operator (ERO) and asked him to stop the pump; at this time the ERO noticed that the Motorman's breathing sounded labored over the radio. Communication was broken off, and the ERO pushed the E-Stop and tried to re- contact the IP to see if he was all right. When there was no response he proceeded to personally check on him. Arriving at the scene, the ERO found the IP lying face down on the Deck, with obvious signs of a head injury.

1. Safe Job Analysis was not properly executed
 - Fall protection was not identified/or worn
 - Risk of H₂S being present in the tote was not identified
2. Leadership/Planning/Guidance
 - Near-miss reported on June 14/04 regarding an H₂S alarm being activated when transferring fluids from the OBM Tank to the Mud Pits was not followed up in a timely manner
 - Formal procedure controlling the risks for transferring fluids from both the hazardous drain tank and/or OBM to the Mud Pits or Tote Tanks was not developed prior to this incident
3. H₂S was generated due from stagnant salt water and rain water in the drains from around the rig and the hot temperatures

1. IP fell from;
2. Hit his head on green tank;
3. Found on deck;
4. Helmet location.

- Developed procedures for transferring fluids from the Hazardous Drain Tank and/or the OBM Tank to the Mud Pits, Tote Tank or Over the Side. Procedures include such safety measures as;
 - Continuously monitoring for H₂S during the transfer;
 - Treating tanks if H₂S alarm reaches 5ppm;
 - Transferring fluids to the tote tanks from the bottom of the totes instead of from the top;
 - Ensuring that personnel involved in the transfer process are either on the ground monitoring fluid levels or on a higher level (but not on top of the tote tank)
- All Tote tanks were immediately tested for H₂S and treated as required. The tote tank involved in this incident was treated.
