Safety Alert

ALERT 04 – 42

CASING RUNNING INCIDENT RESULTS IN LTI

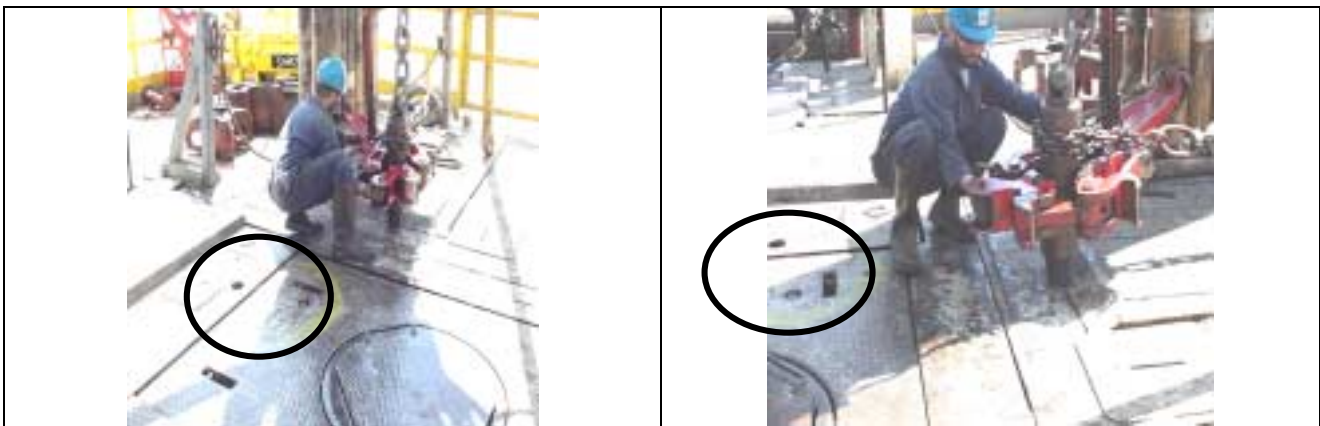
Black circle is point to spider elevator place beside well hole

Placing the extension on the rig floor and not in the mouse hole did not provide good stability for final make up torque. The placement of the spider elevator on the rig floor made a tight work place and the IP worked between fill line arrangement and spider elevator. Since they could not rotate the rotary table, the top drive in the extended position was used to torque the extension. By not having the proper extension was not available, third Party Company failed to comply with equipment requirement. Company safety procedures not followed, supervisors conducting this operation on rig floor directly instead of the mouse hole. Inadequate task preparation, Supervisors didn't conduct this operation in the mouse hole and left spider elevator beside the well hole waiting for next job. Lack of safety awareness, Supervisors supporting fill line arrangement by air hoist wires with break failure and tight it with chain sling. Poor supervision, Supervisors didn't maintain a good practice / good supervision because they start making torque while IP still in trapped position between left rig tong and spider elevator. Job risk assessment was not adequate for the task. IP didn't recognize the hazards of the task or his position.

- Prior to beginning operations, third party equipment is to be checked to ensure proper equipment is on hand.
- A JSA including a risk assessment is to be conducted prior to changes in procedures.
- Supervisors are to follow company policy requiring the mouse hole to be used to steady connections.
- Personnel are to be instructed to stay out of possible trap areas.
