# Safety Alert

ALERT 04 – 50

## STABBING BOARD FALL TO RIG FLOOR RESULTED IN A FATALITY AND SERIOUS INJURY

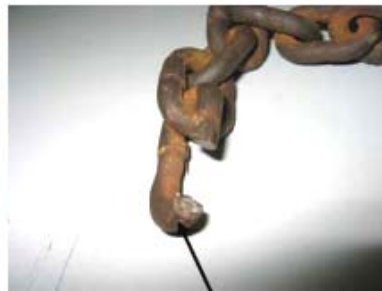
Chain Snapped

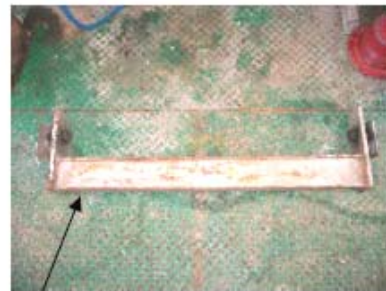
Stopper plate not in position

- The stabbing board was installed without the safety stopper plate at the bottom of the rail
- The lifting gear used was not part of the rig's lifting register
- The Derrick man did not connect properly the safety belt he was wearing
- The safety working load of the manual chain block was not in accordance with the requirements
- The derrick man did not use the primary safety dogs to keep the stabbing board in position and the chain was not in tension at the moment he released the upper safety dogs.

- Introduced Management of Change procedure
- Improved the procedure to install the stabbing board
- Improved the onboard management of the lifting appliances and include all the hoisting gear in the lifting register.

- Upgraded the stabbing board safety lower dogs system
- Improved the safety awareness on board through training sessions.
