# Safety Alert

## ALERT 06 – 25

### POOR QUALITY LIGHT FIXTURE CAUSES FIRE

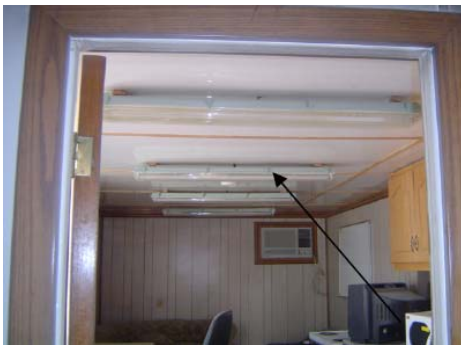
- Overheating / open circuit ballasts
- Carcasses which crack / break in a matter of weeks allowing fittings to hang from cables or fall from ceiling.
- The lamp assembly retaining clips fail prematurely allowing the lamps and tray to fall on diffuser which can melt the plastic.
- In a matter of months, the foam seals seem to "vulcanize" the body to the diffuser and tear when the light is opened for inspection.
- Diffuser retaining clips which become brittle and break off.
- Drastically reduced life expectancy when mounted externally even though they are IP65 rated fittings.

Normally used light fittings

- Management to agree on a standard good quality approved replacement light fixtures.
- Only those lights which have been approved by management are to be ordered.

- Lights currently in place will be progressively changed out.

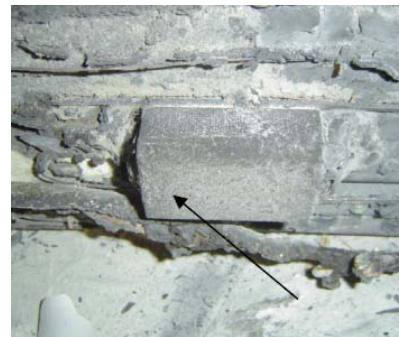
The cause of the fire was an overheating ballast (choke) until in an enclosed 240 volt 1200mm twin fluorescent light which melted/ignited the enclosure plastic before the main circuit board tripped. This is not the first case of fire caused by overheating ballast. Another fire occurred in late in 2005 in a rig store room. In addition to these two known fires, there have been over 90 ballasts have been changed out in the last 2 years.

Overheated ballast (main cause of fire)
