ALERT 14 – 22

SELF-RETRACTING LIFELINE (SRL) ANCHOR POST FAILURE RESULTS IN NEAR MISS

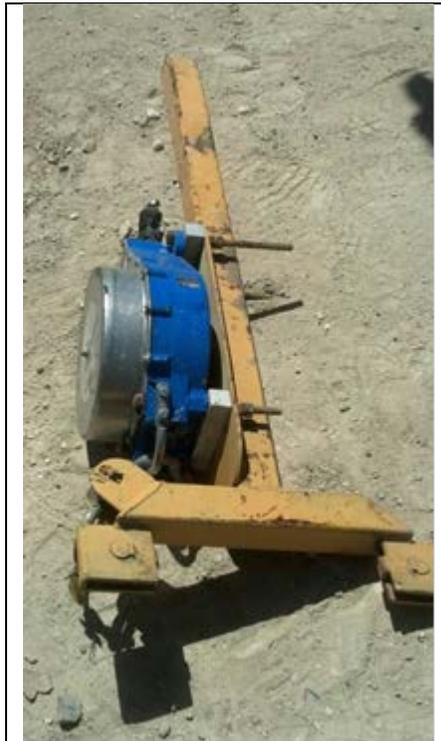
The rig crew was drilling ahead when a third party employee drew their attention to the rig's crown. The crew looked up and noticed that the SRL anchor post was hanging from the retracting line to the side of the mast. Operations were immediately stopped and the crew discovered that the SRL anchor post had fractured at the top of the gusset. It then apparently fell towards the mast and came to rest when it impacted the SRL. The cable was tied to an SRL and the SRL was lying over the top of the crown.

The SRL was installed on a climb assist anchor post. Years of fatigue due to moving the rig from location to location, impacting the SRL during daily inspection testing, and the most recent jarring operations were all identified as causes that lead to the SRL post fracturing at the top of the gusset.

- Inspect all posts where SRL housings are currently mounted.
- Have the rig crew engineer the anchor post utilizing current MOC practices.
- Increase the frequency of a qualified comprehensive inspection of the SRL anchor post.
- Install a secondary restraint for the SRL anchor post that is attached to a structural member.
